VETIVER SYSTEM FOR FLASH FLOOD EROSION CONTROL OF LEVEE BANKS AND SEA DIKES

THE VETIVER NETWORK (INTERNATIONAL)

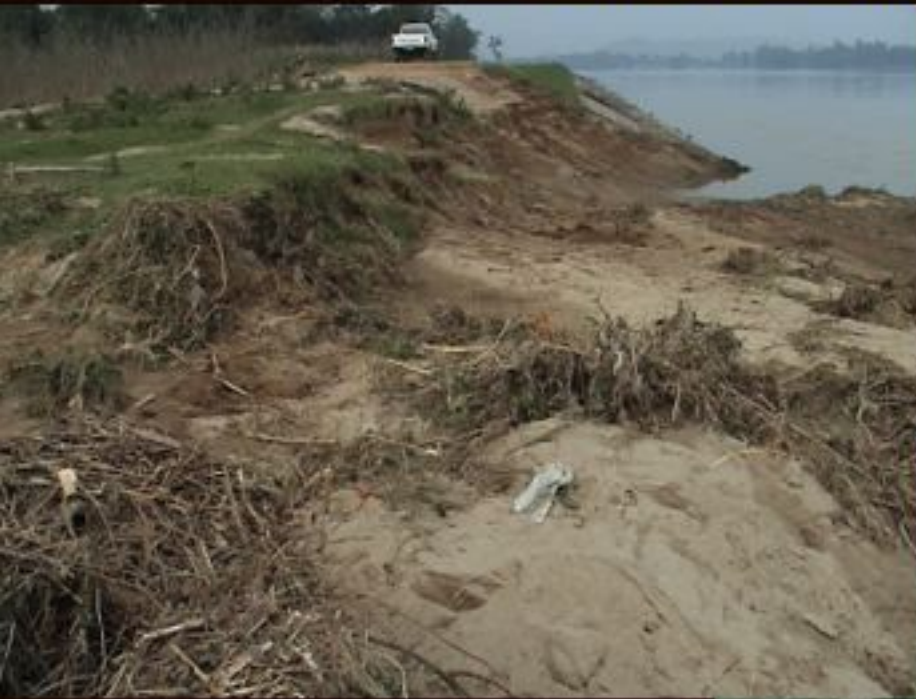
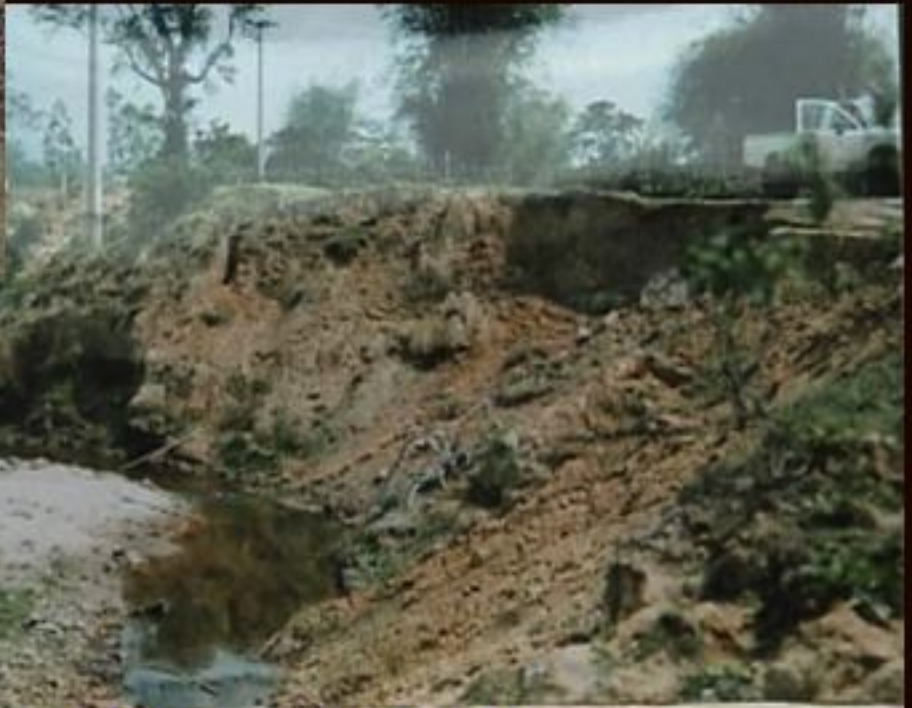
Flash flood caused enormous damage to infrasture such as levee banks in the central coastal provinces of Vietnam

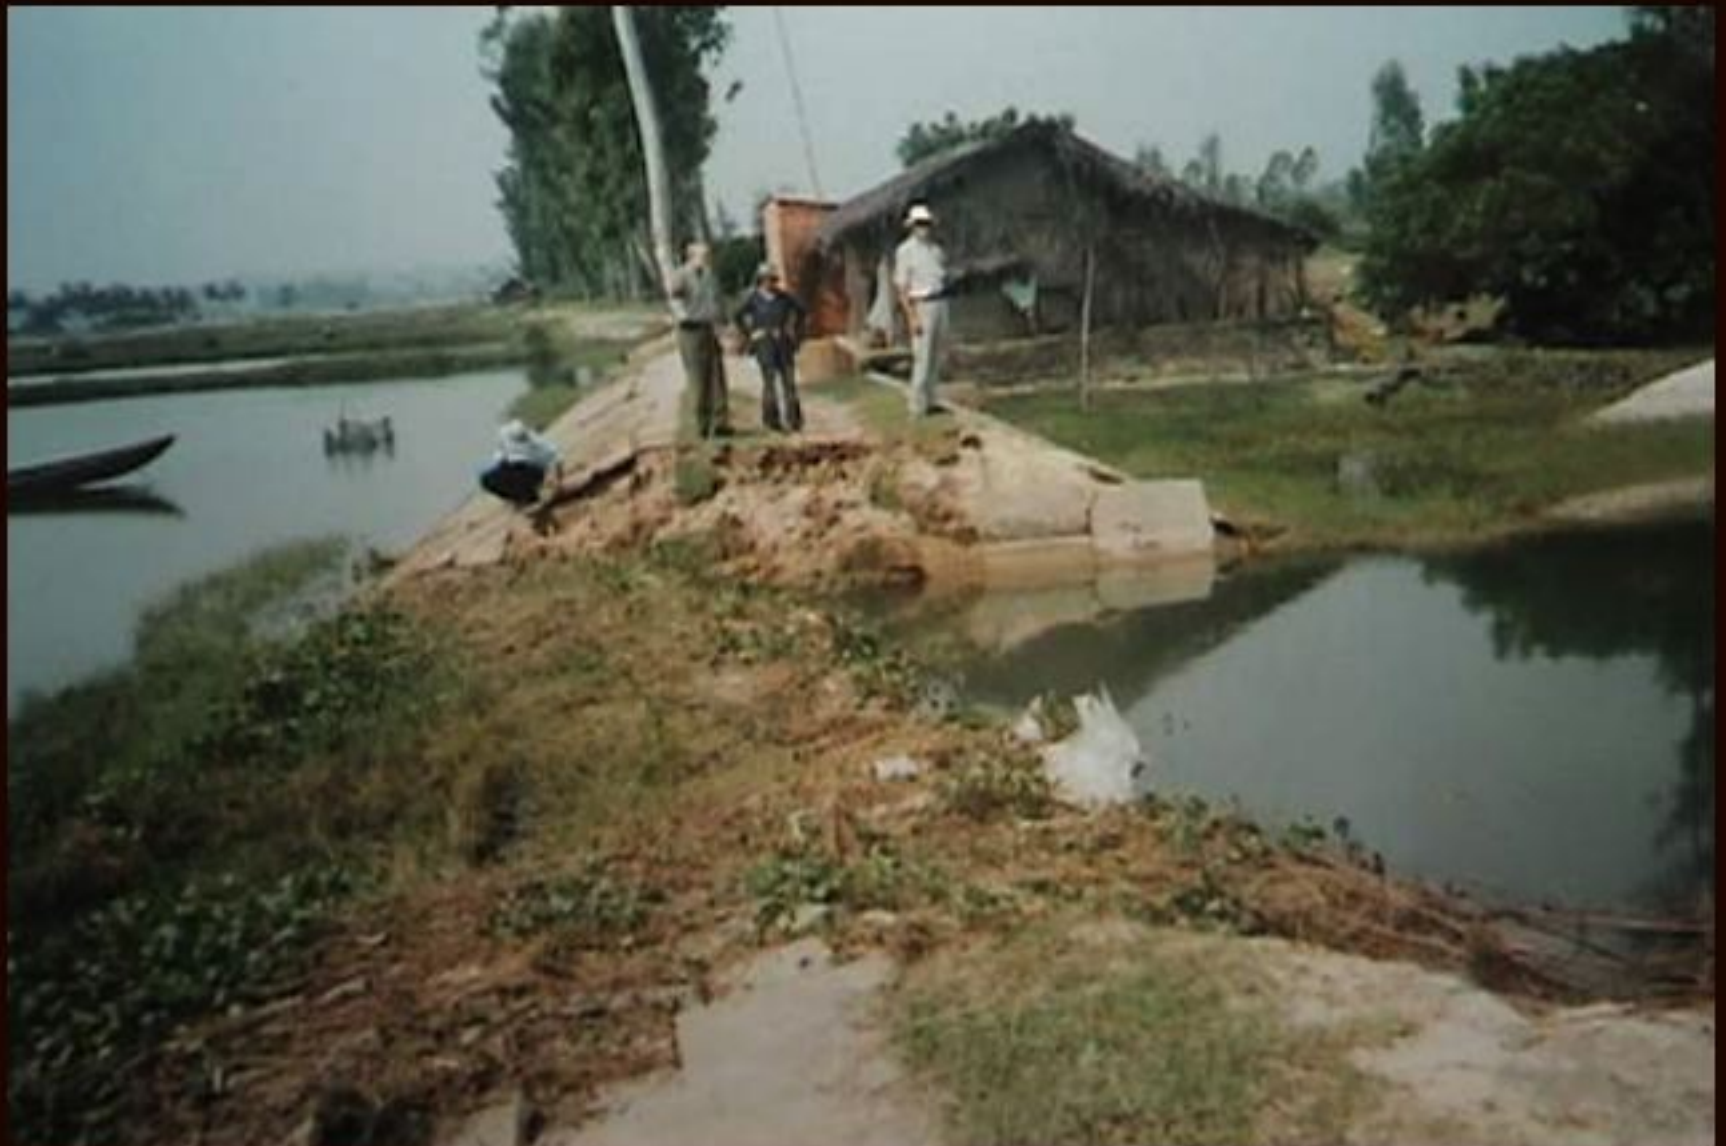
Severe damage to rural roads

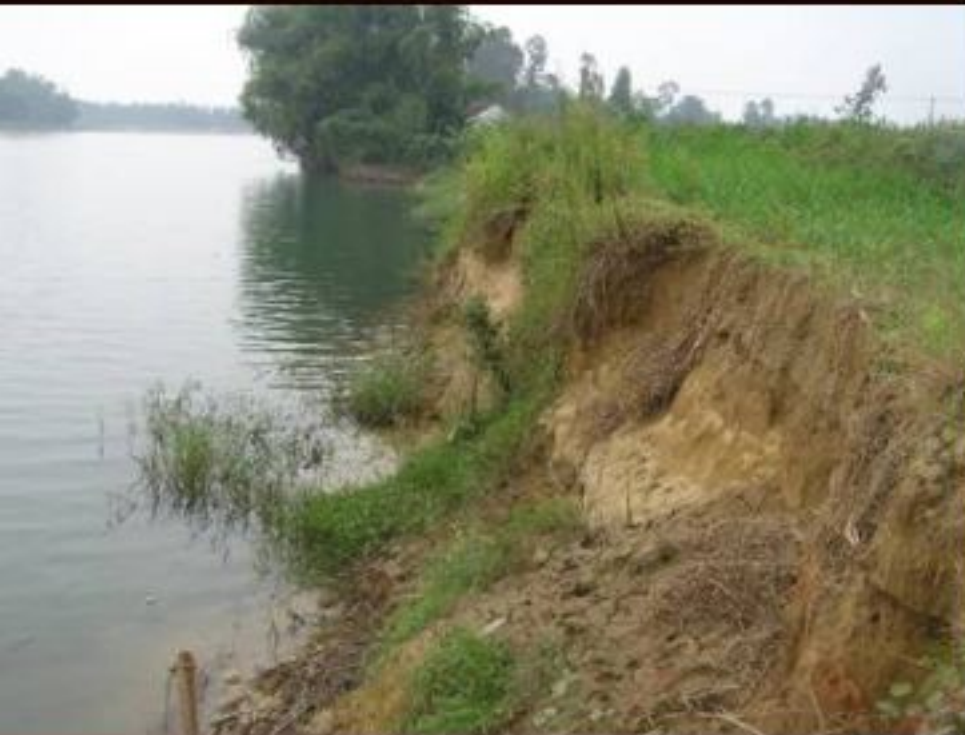
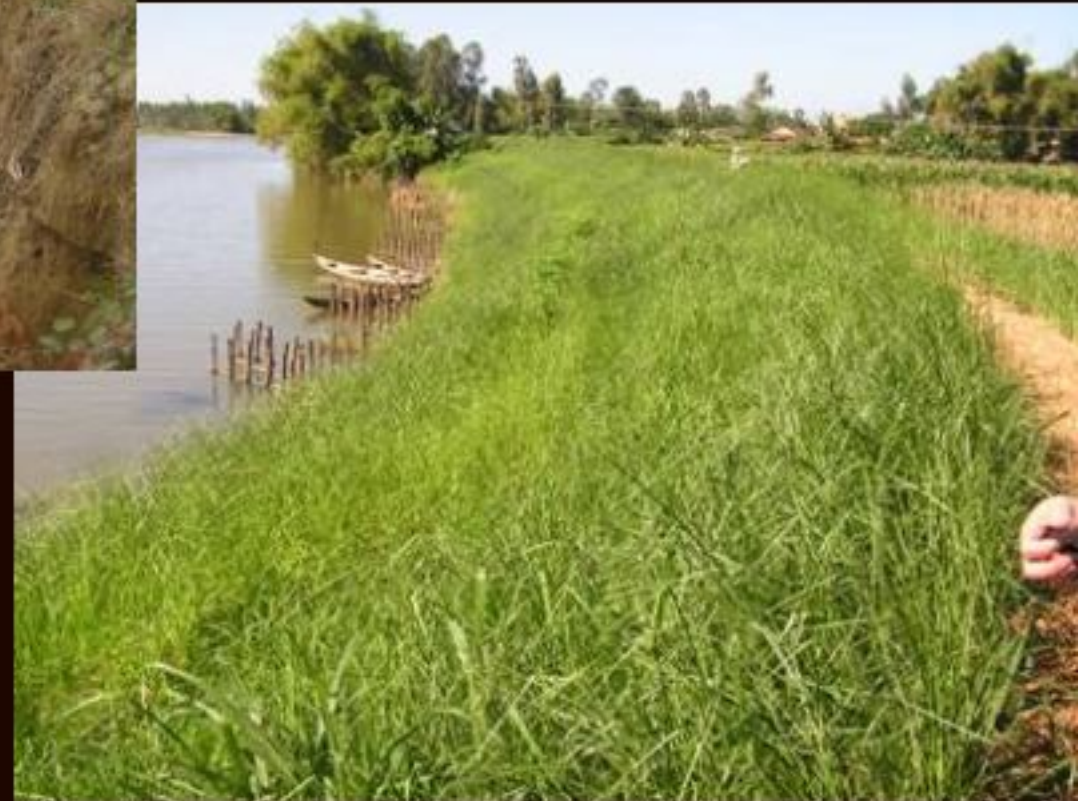
Vetiver stabilisation of river bank before and after

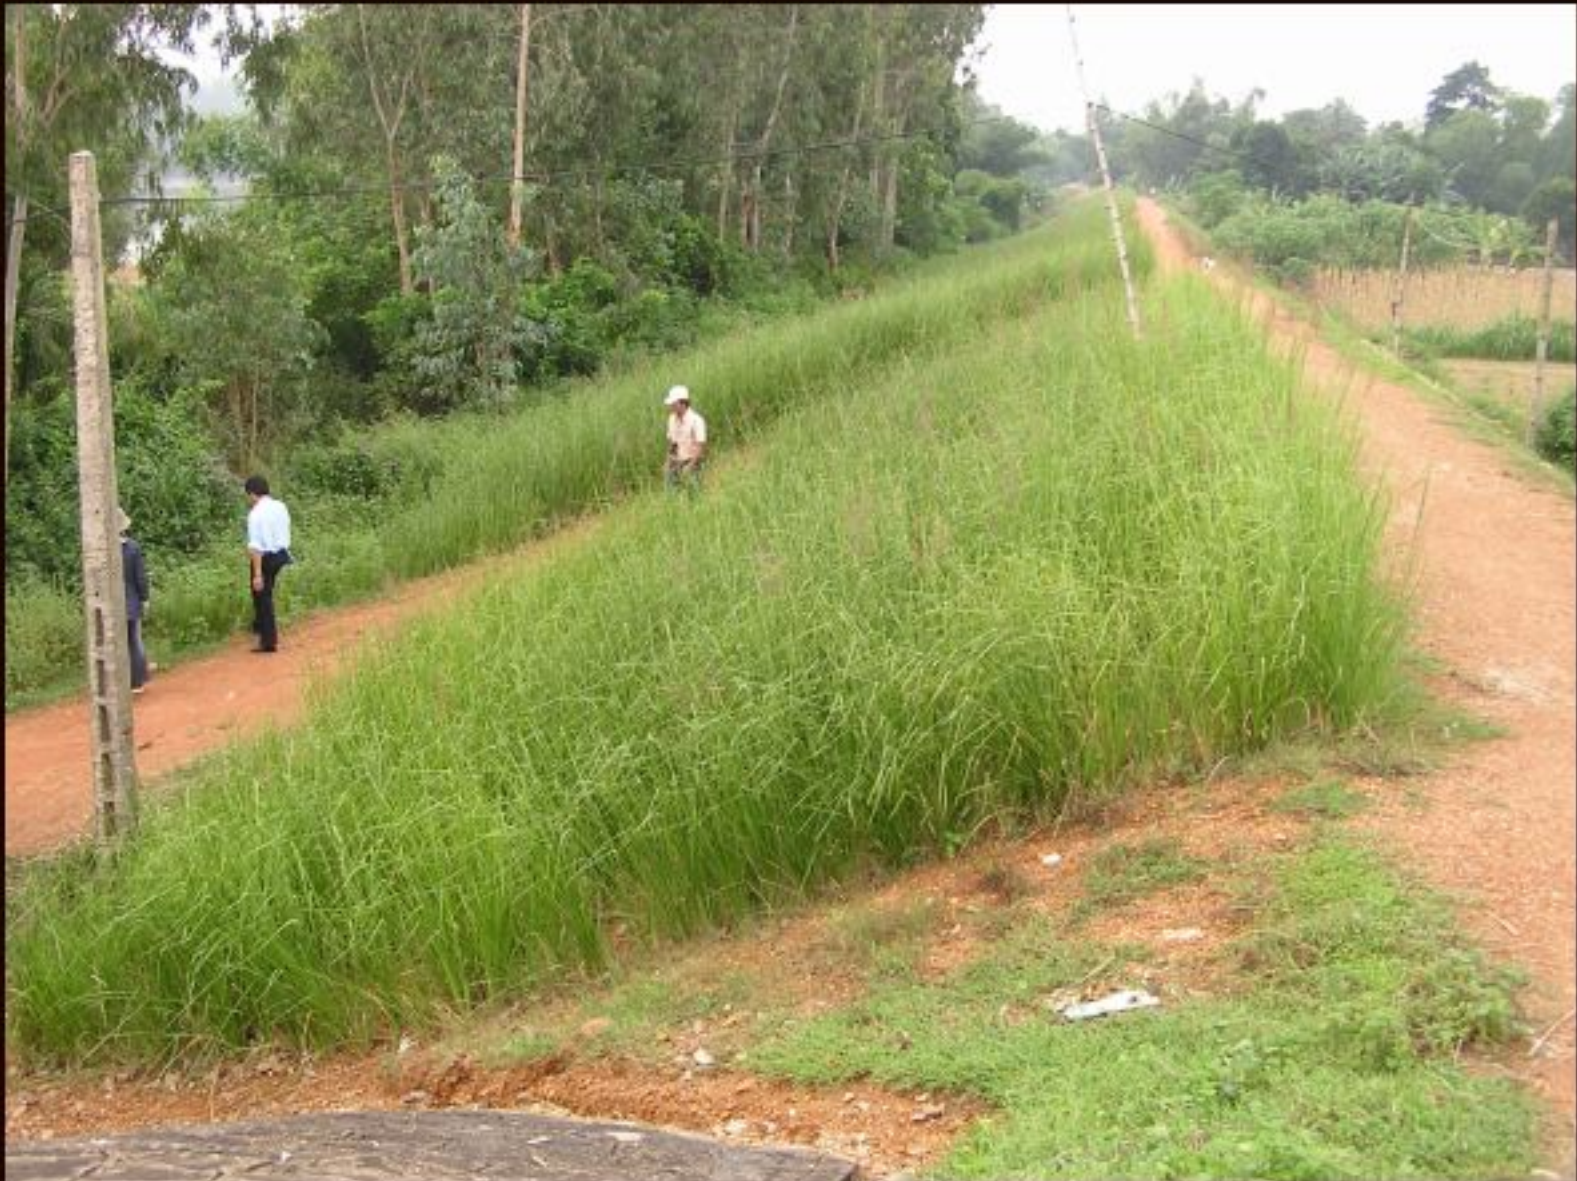
Vetiver stabilisation of a large levee bank

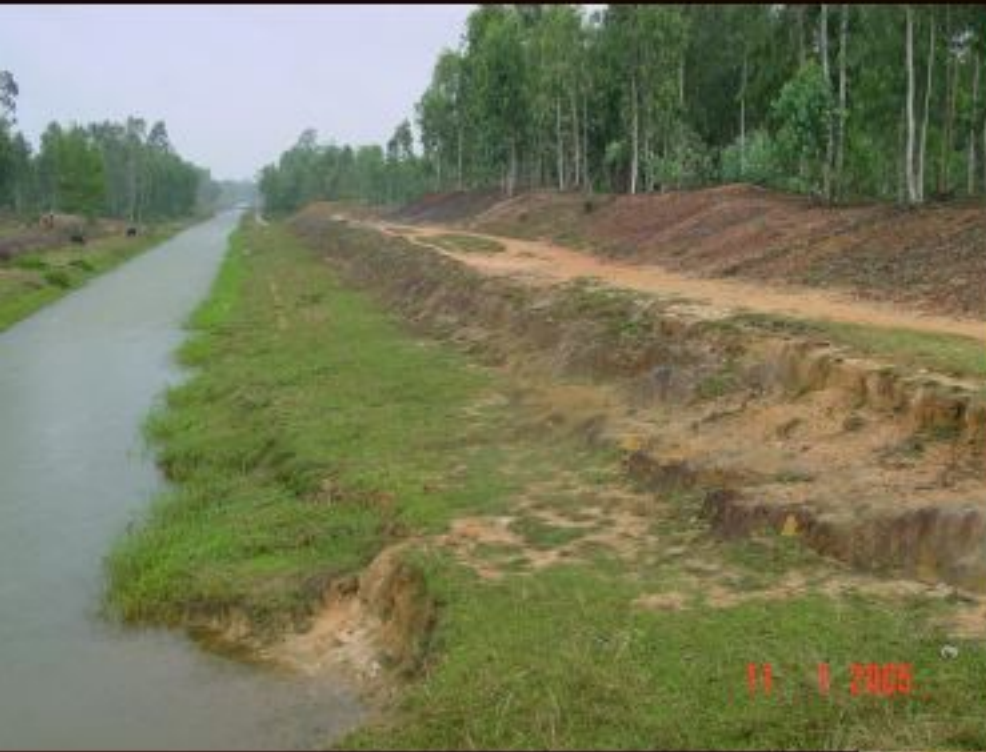
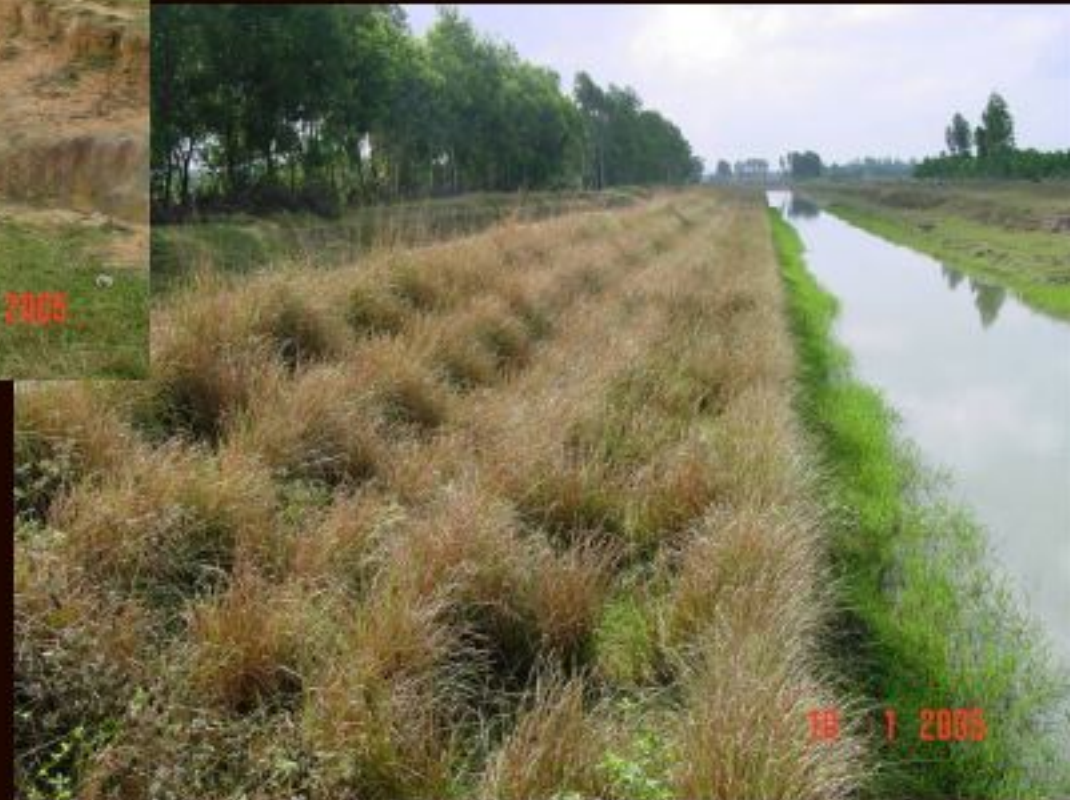
Vetiver stabilisation of drainage channel bank before and after

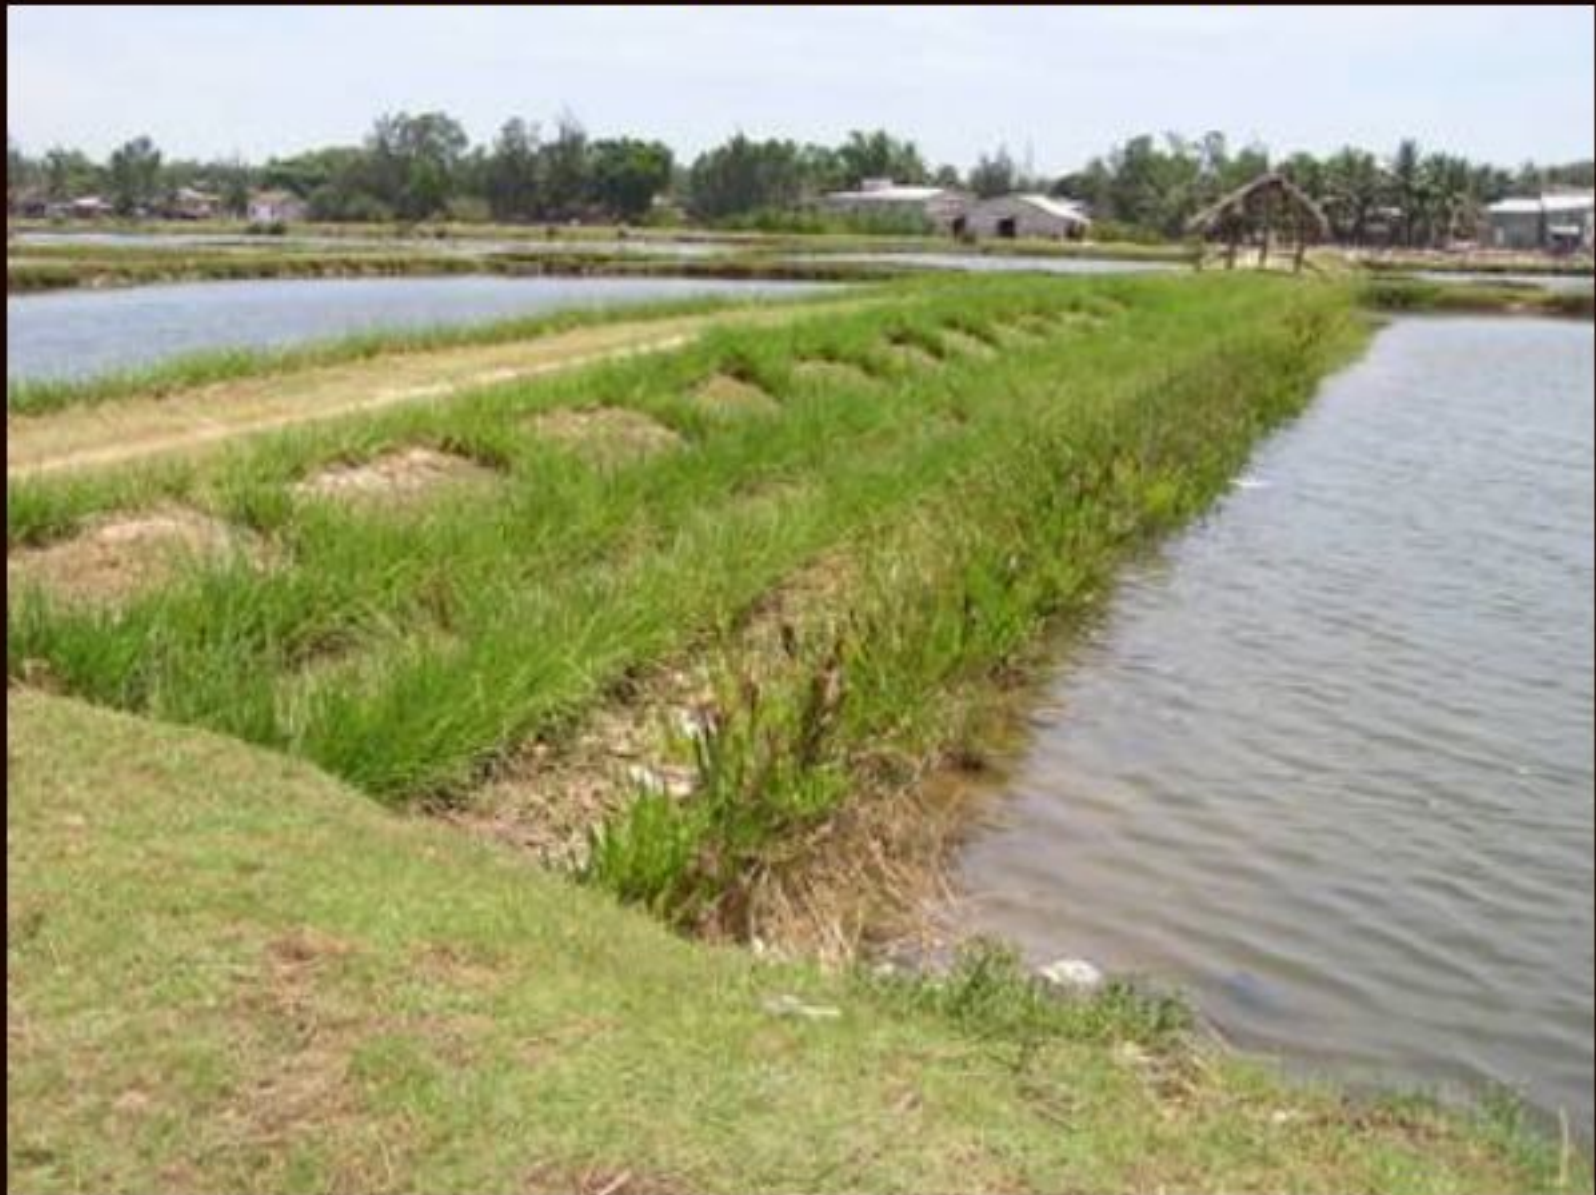
Stabilisation of aquaculture infrastructure

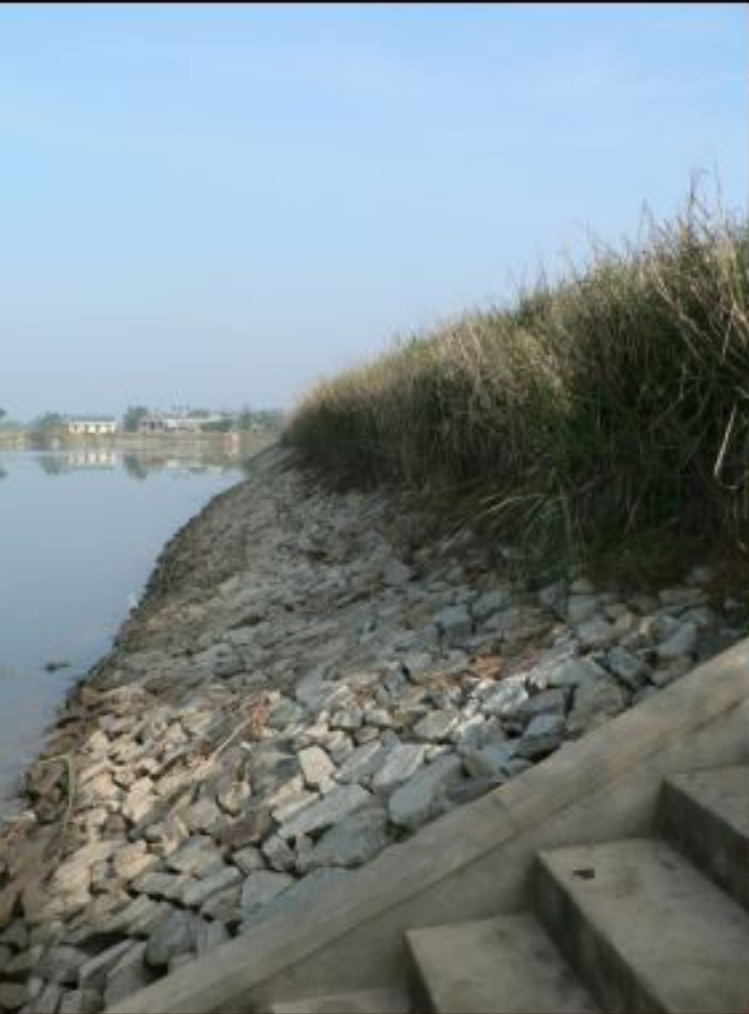
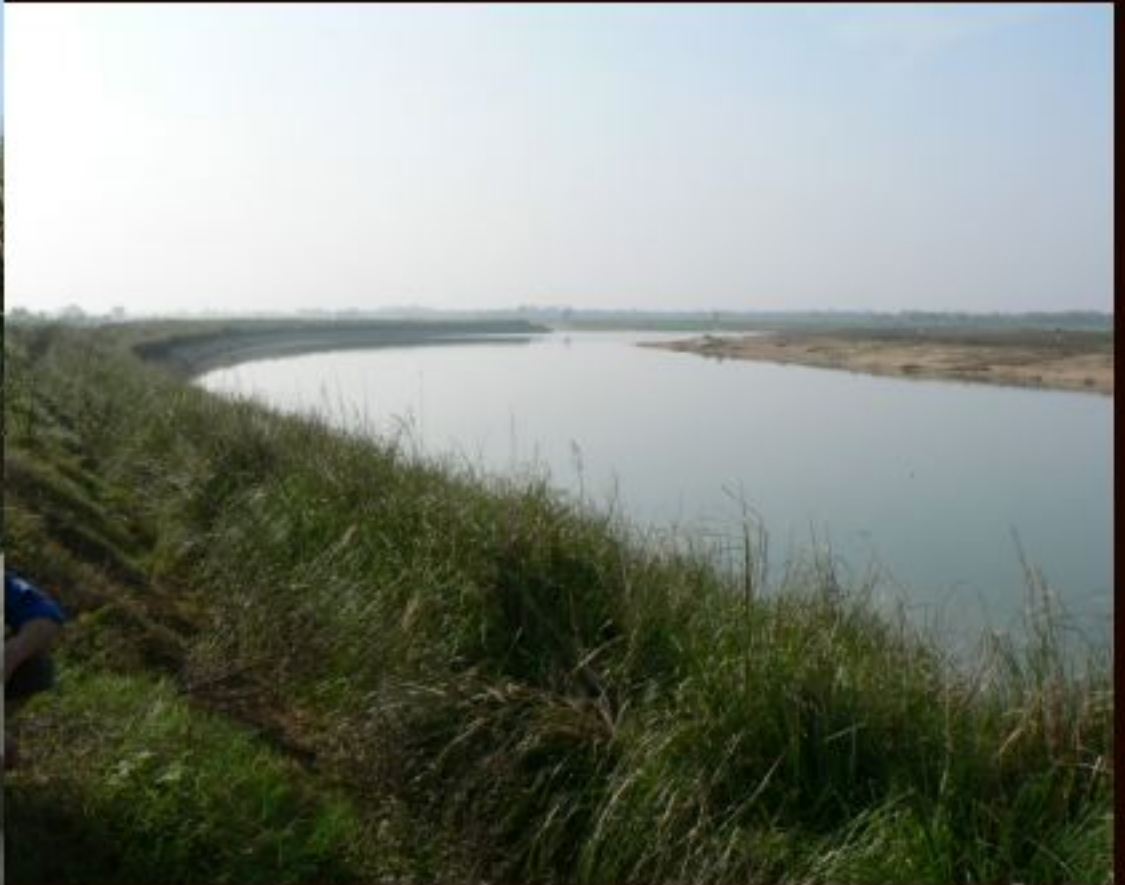
Re-enforcing and protecting hard structure of a river bank

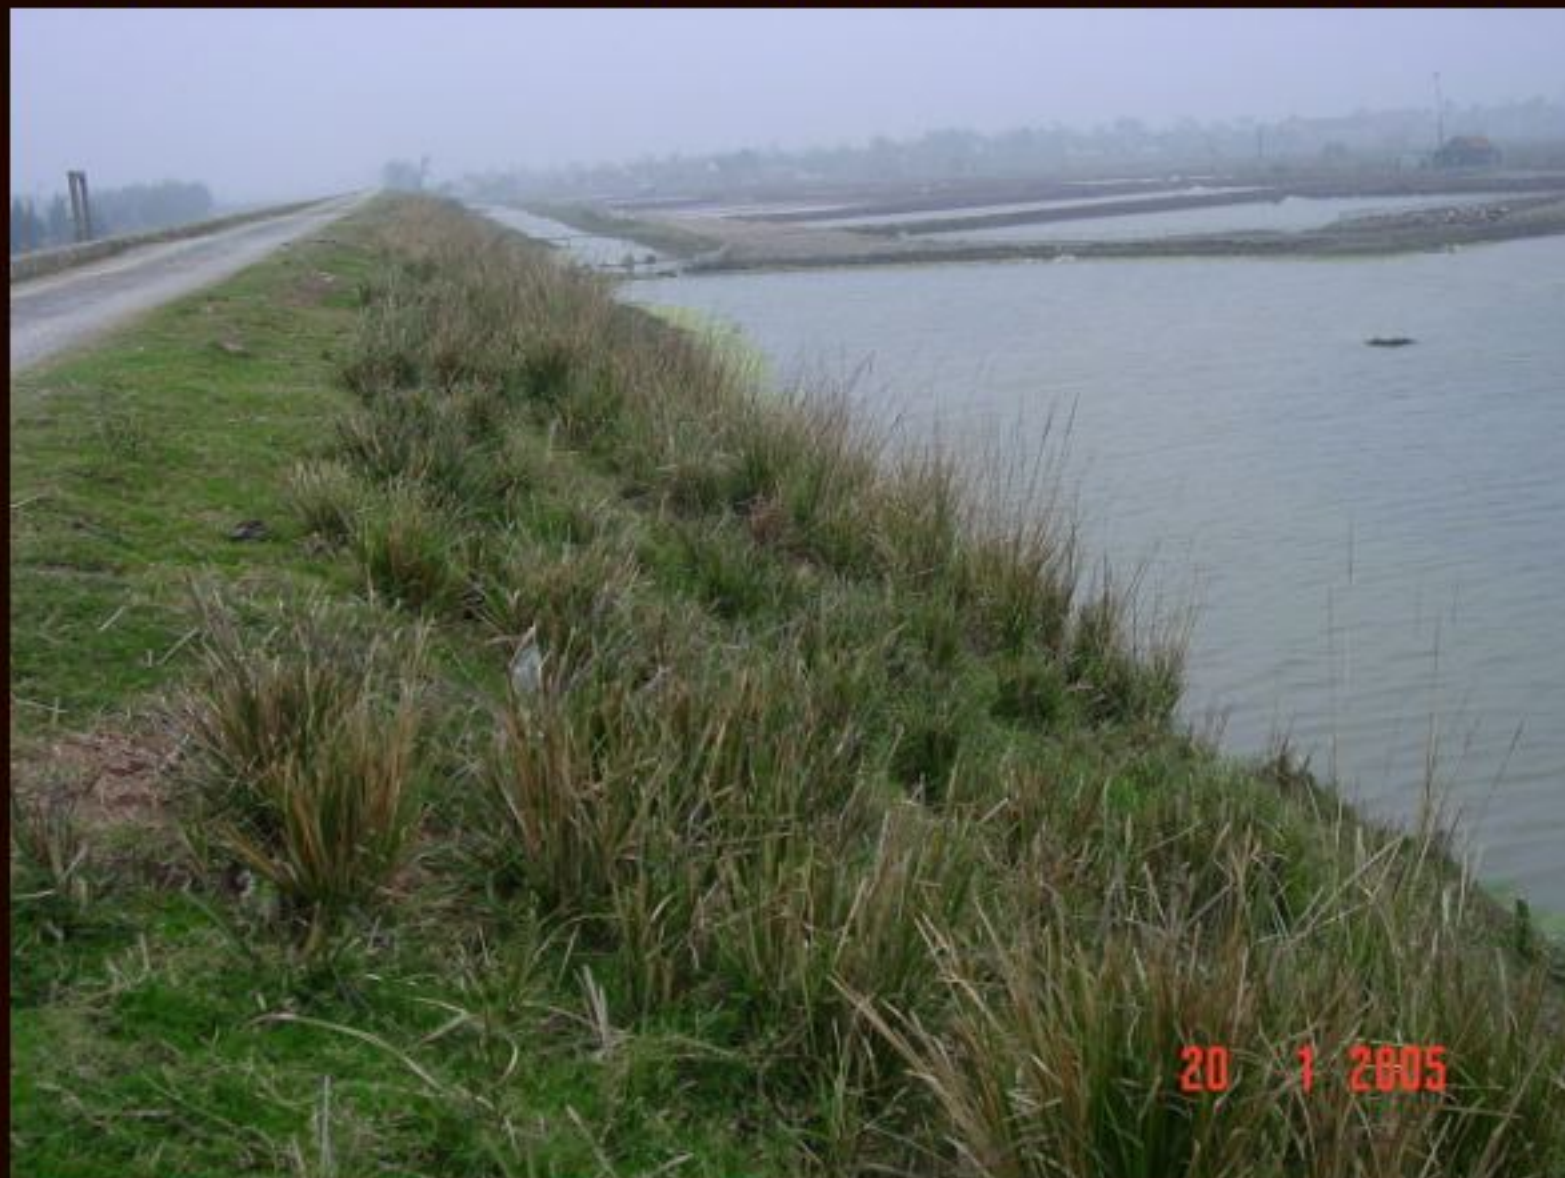
Stabilisation of the inner wall of a sea dike in Nam Dinh province

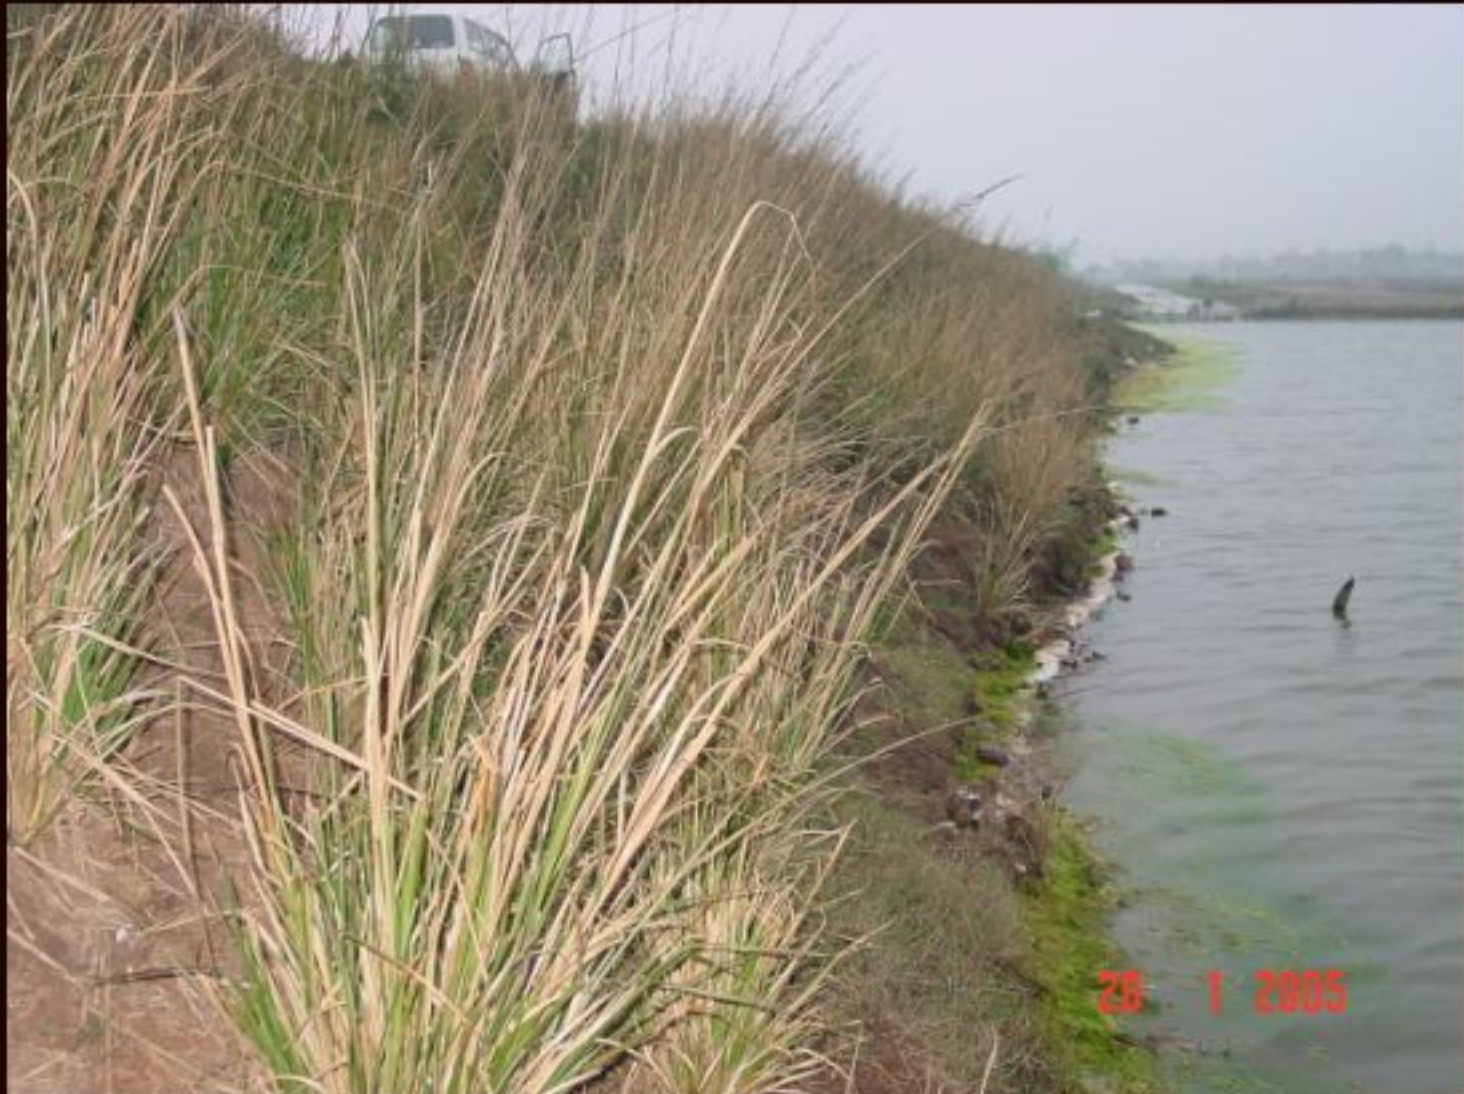
When this dike was over topped by the last typhoon, the unprotected part of the dike was washed away, while the vetiver planted section remained intact.

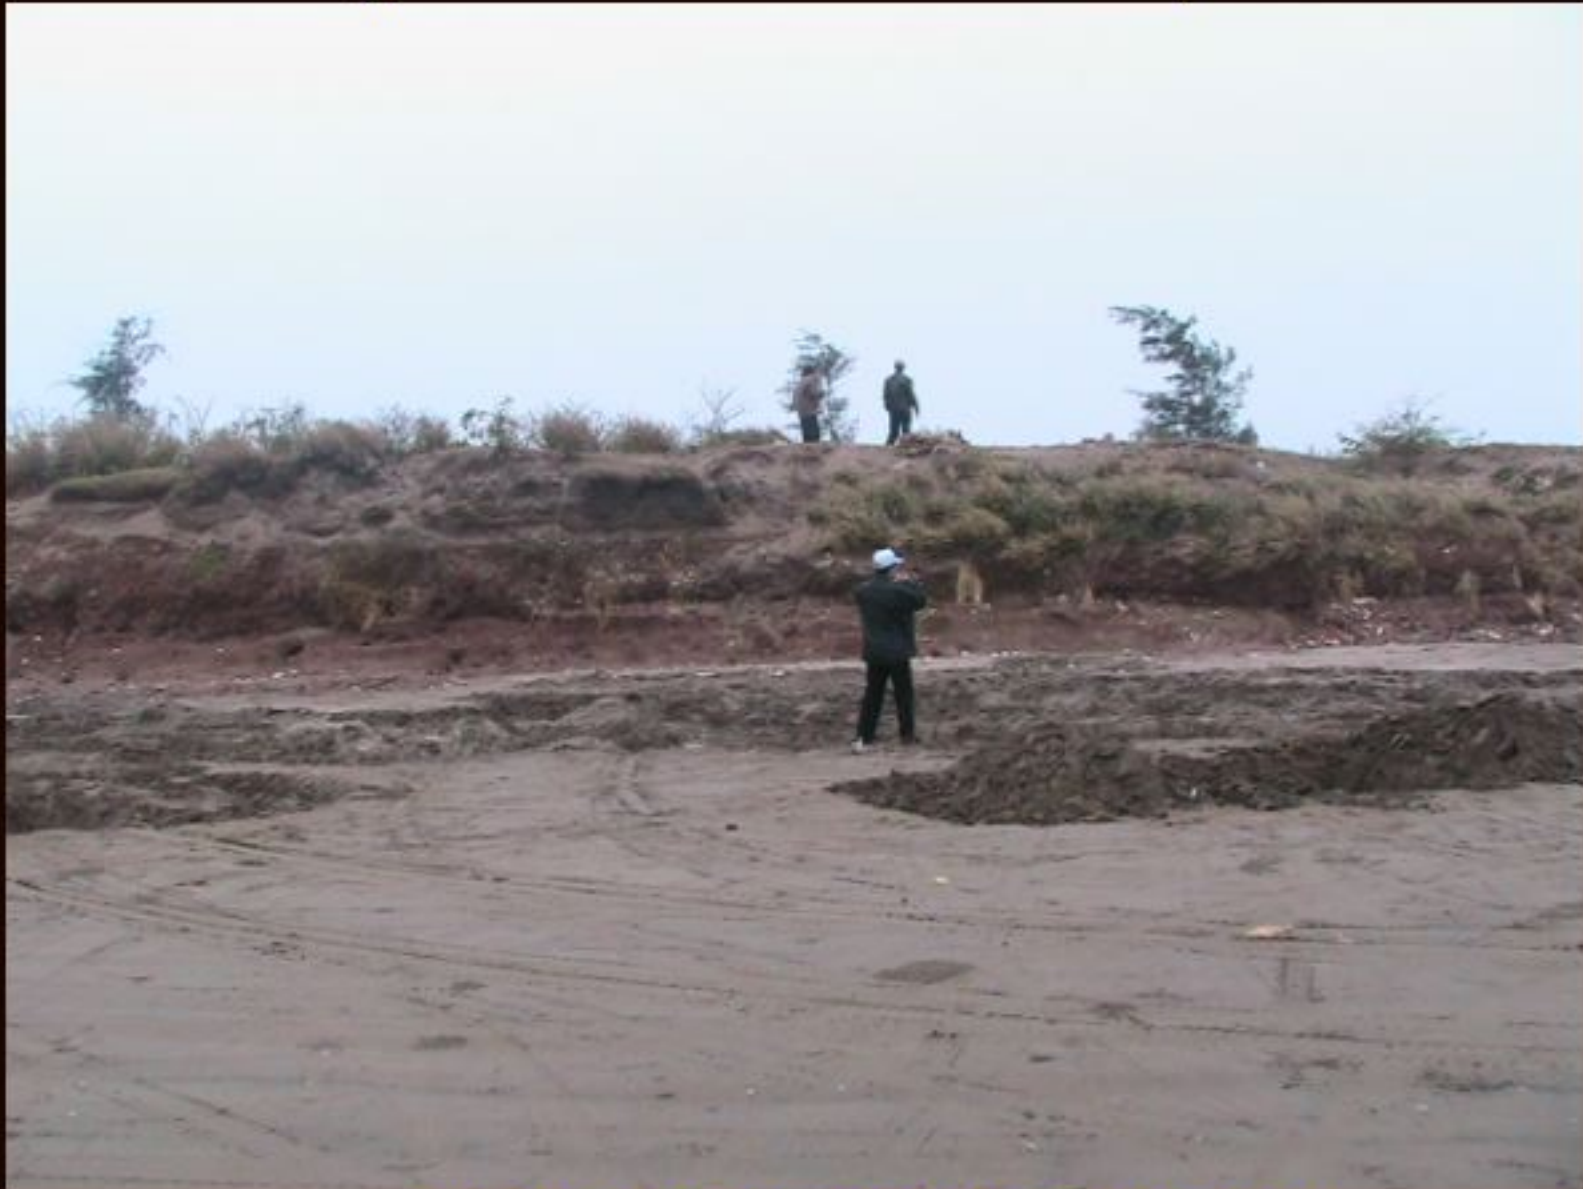
The sea-facing wall of this dike was badly damaged (left) while the right side, planted with vetiver remained fairly stable
