VETIVER SYSTEM FOR FLOOD EROSION CONTROL

THE VETIVER NETWORK (INTERNATIONAL)

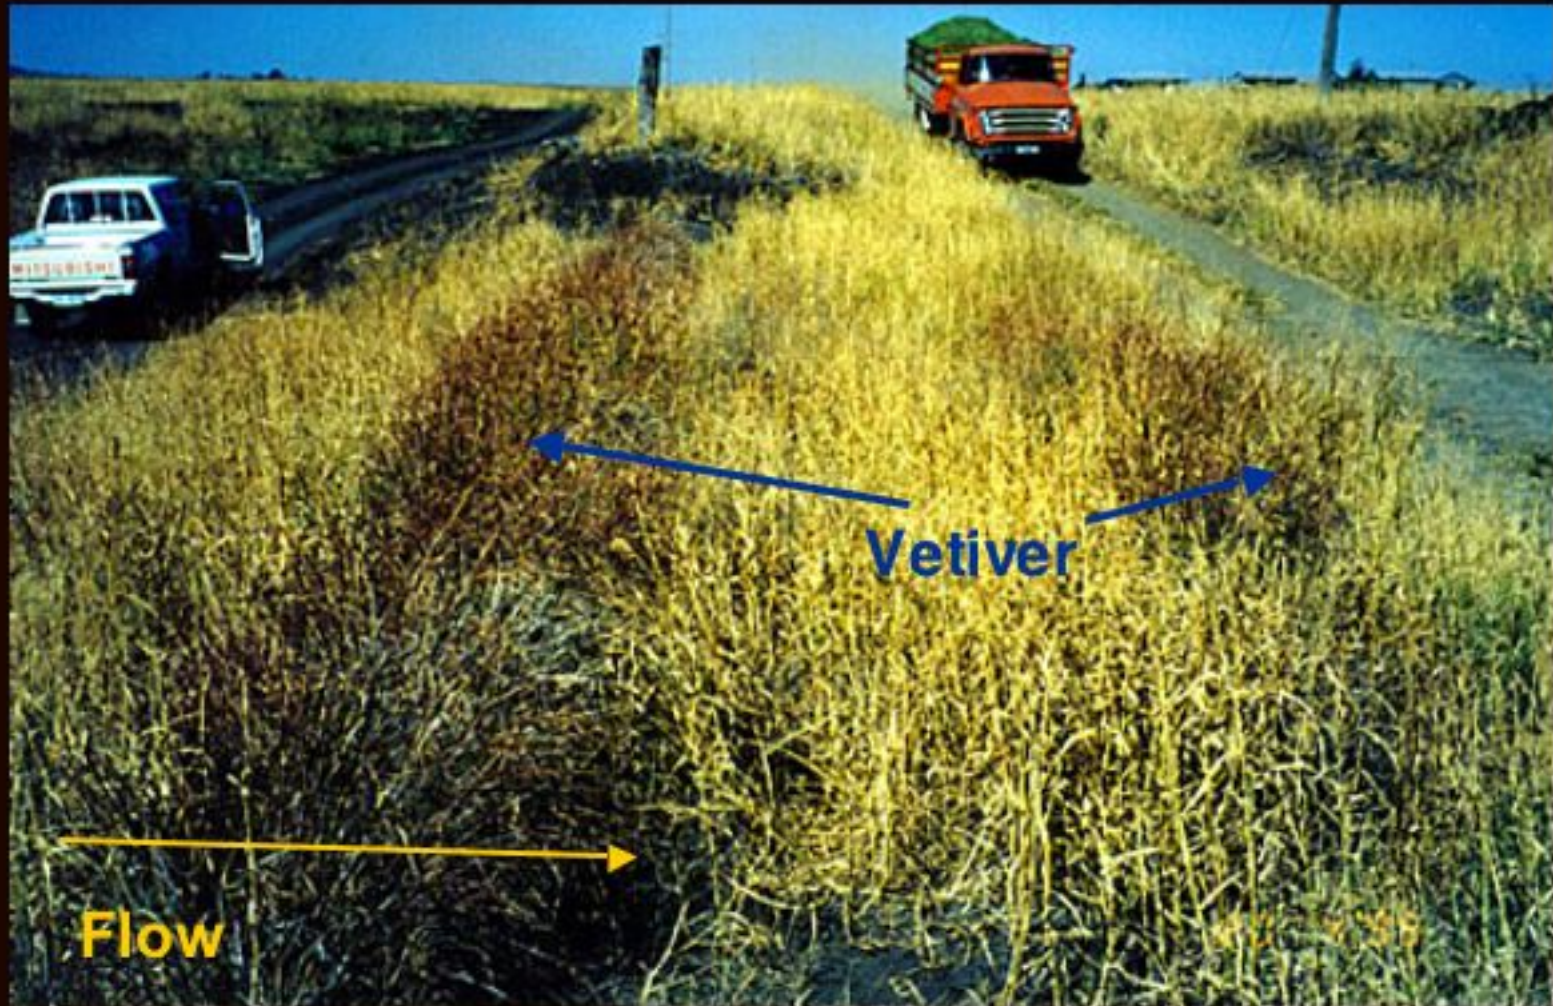
Australia: This concrete causeway on this farm road was often washed away by flood water which undermined the foundation of the concrete surface. Two rows of vetiver planted upstream of the causeway.

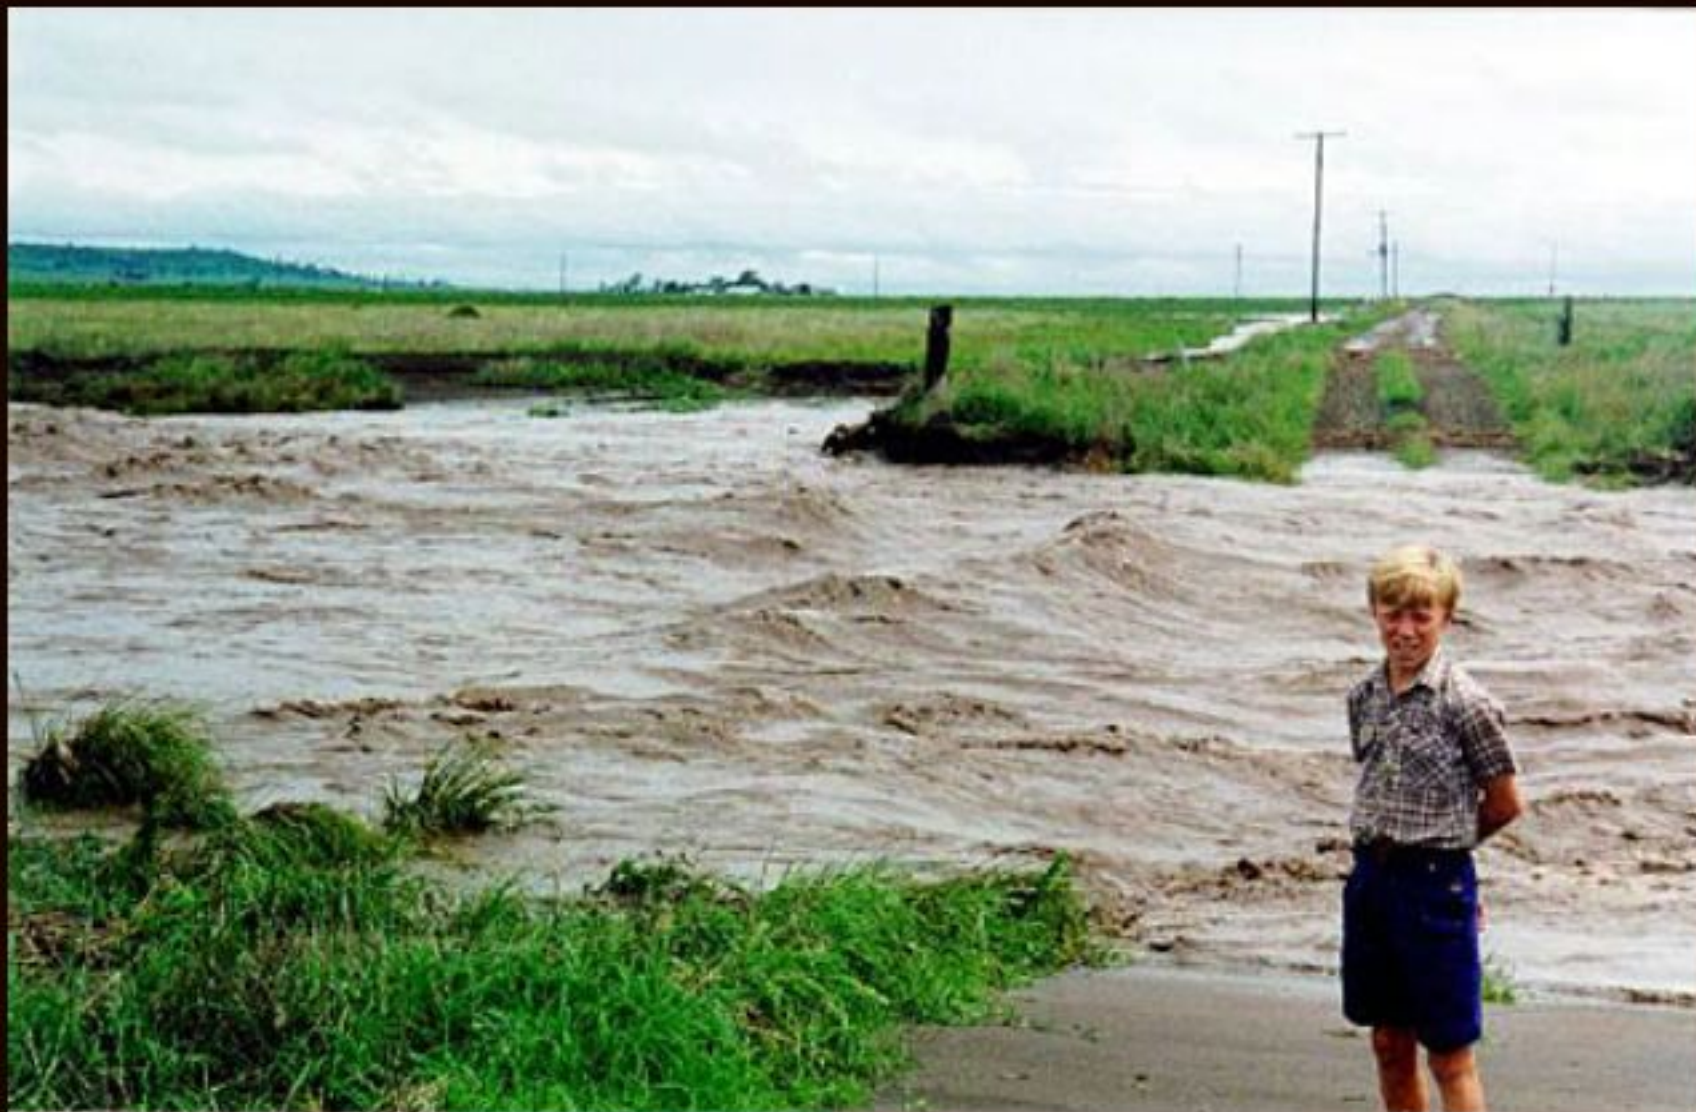
A 3m deep flood swept through this causeway, completely submerged the vetiver rows

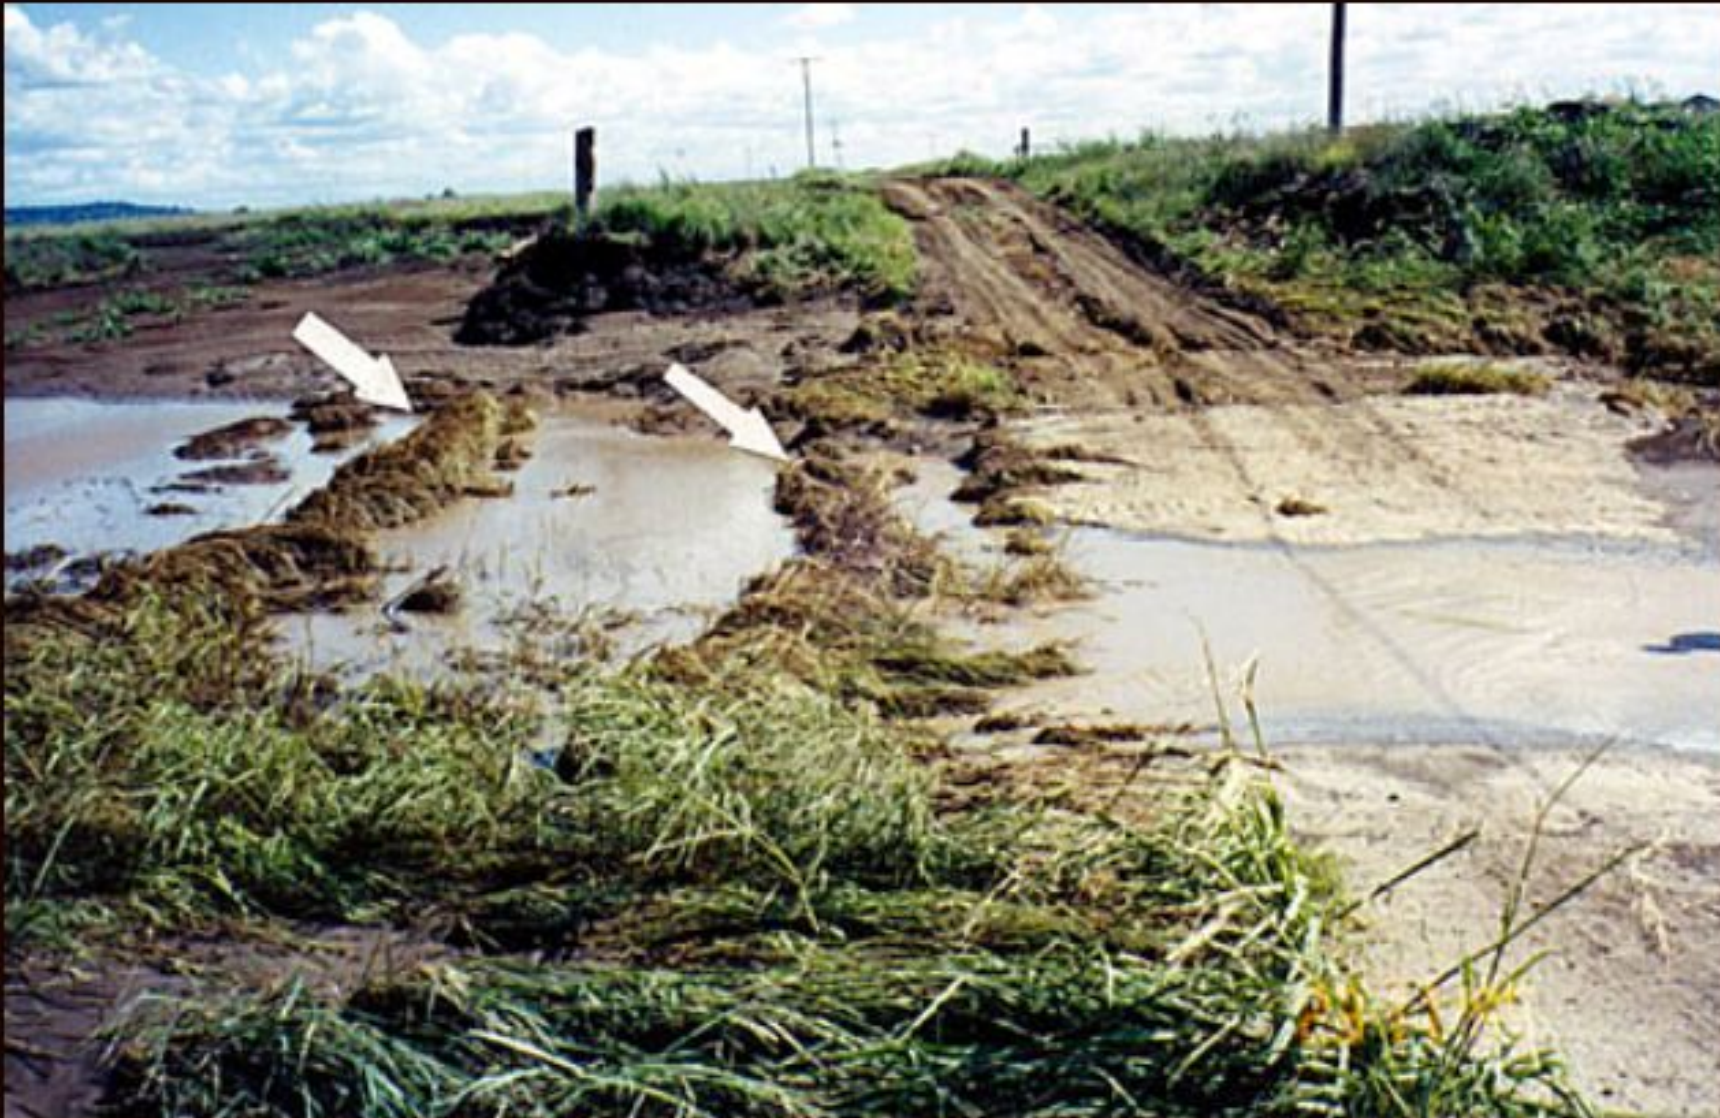
Although badly battered, the vetiver hedges held firm during the flood, preventing the undermining of the concrete causeway

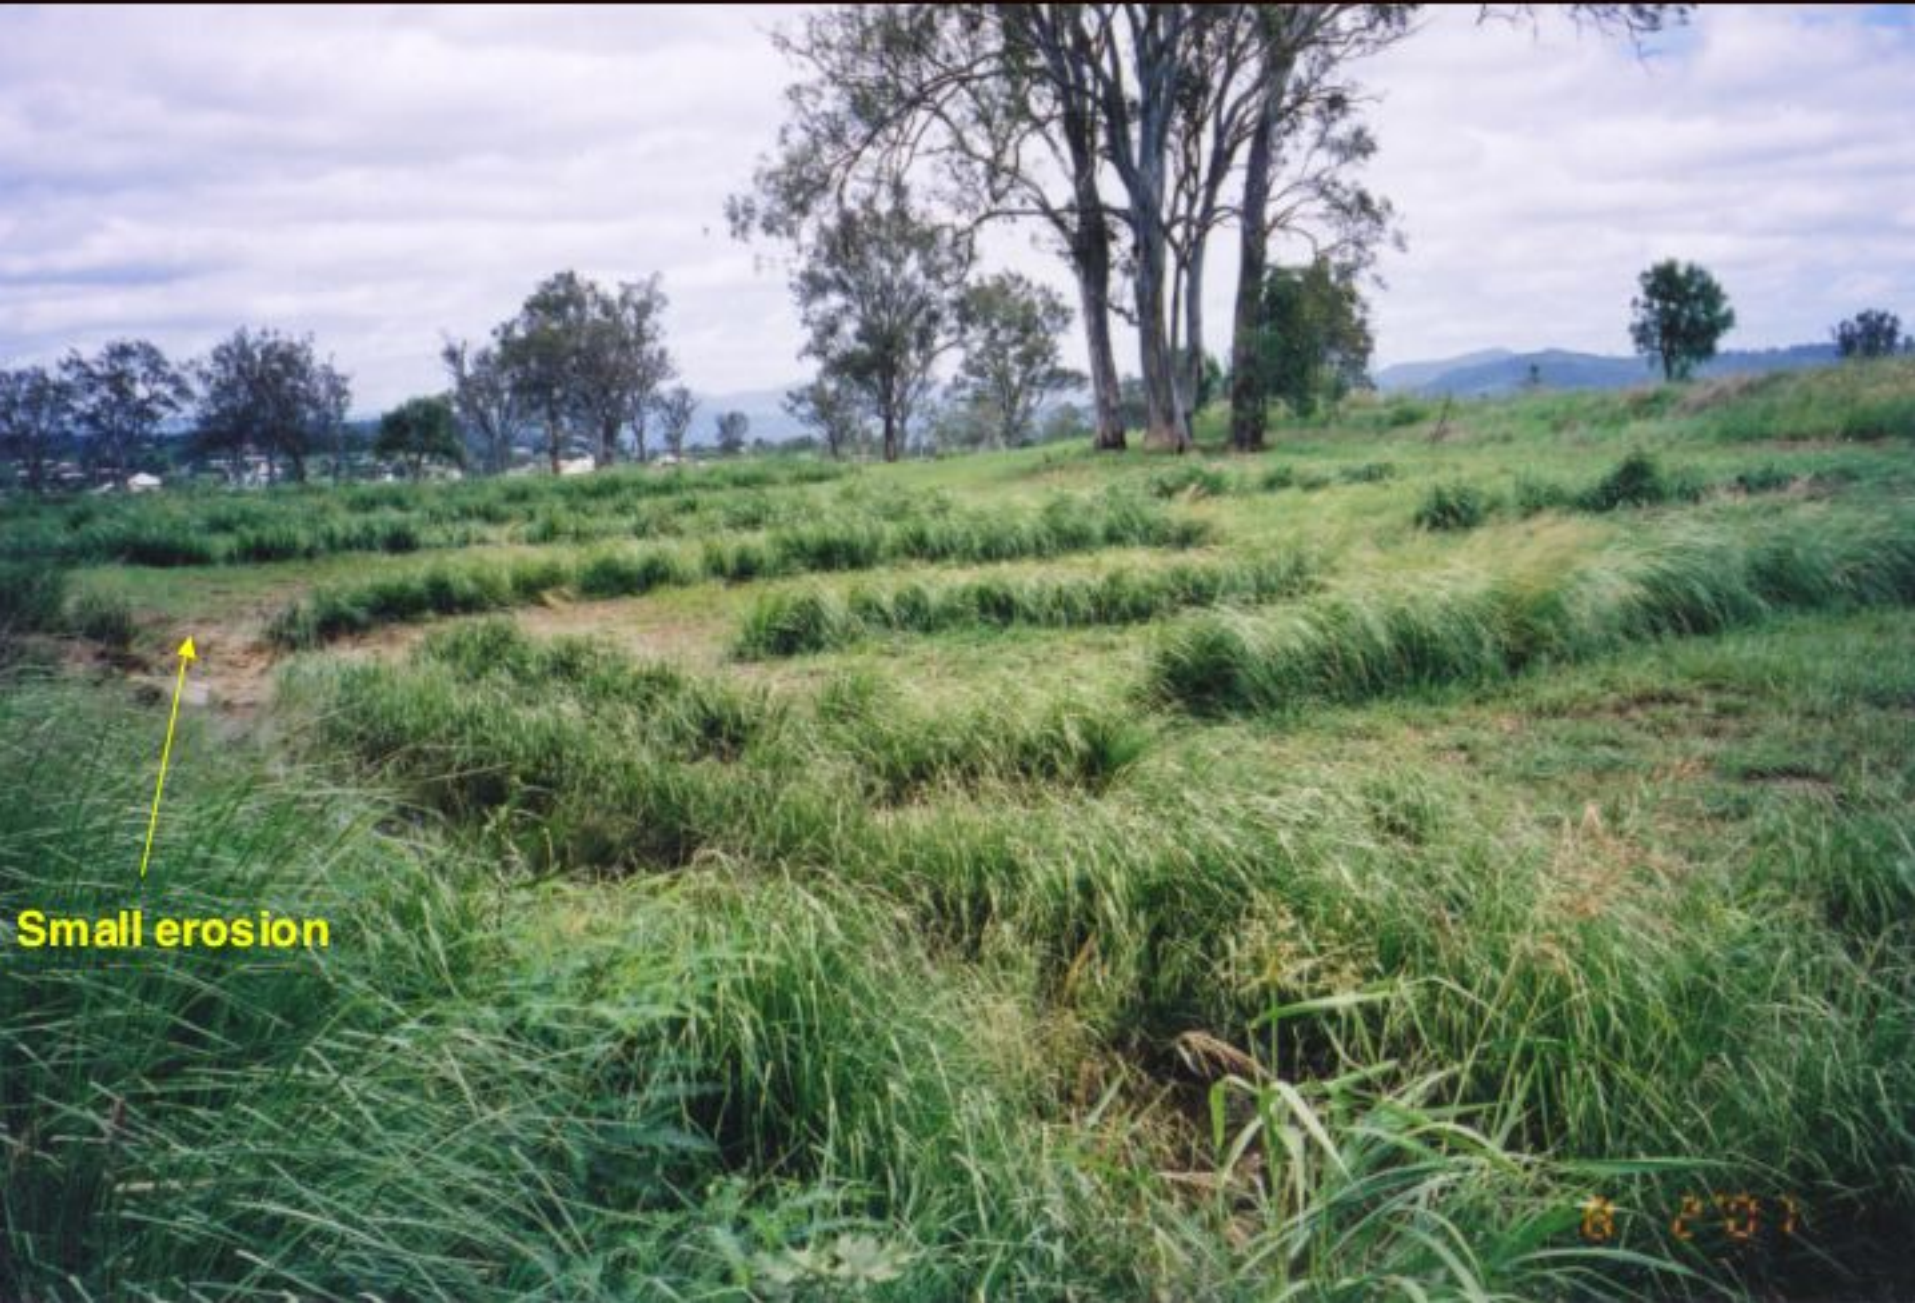
Although only 3 month old, the young hedges provide a very effective protection with only minimal erosion at the head of the channel

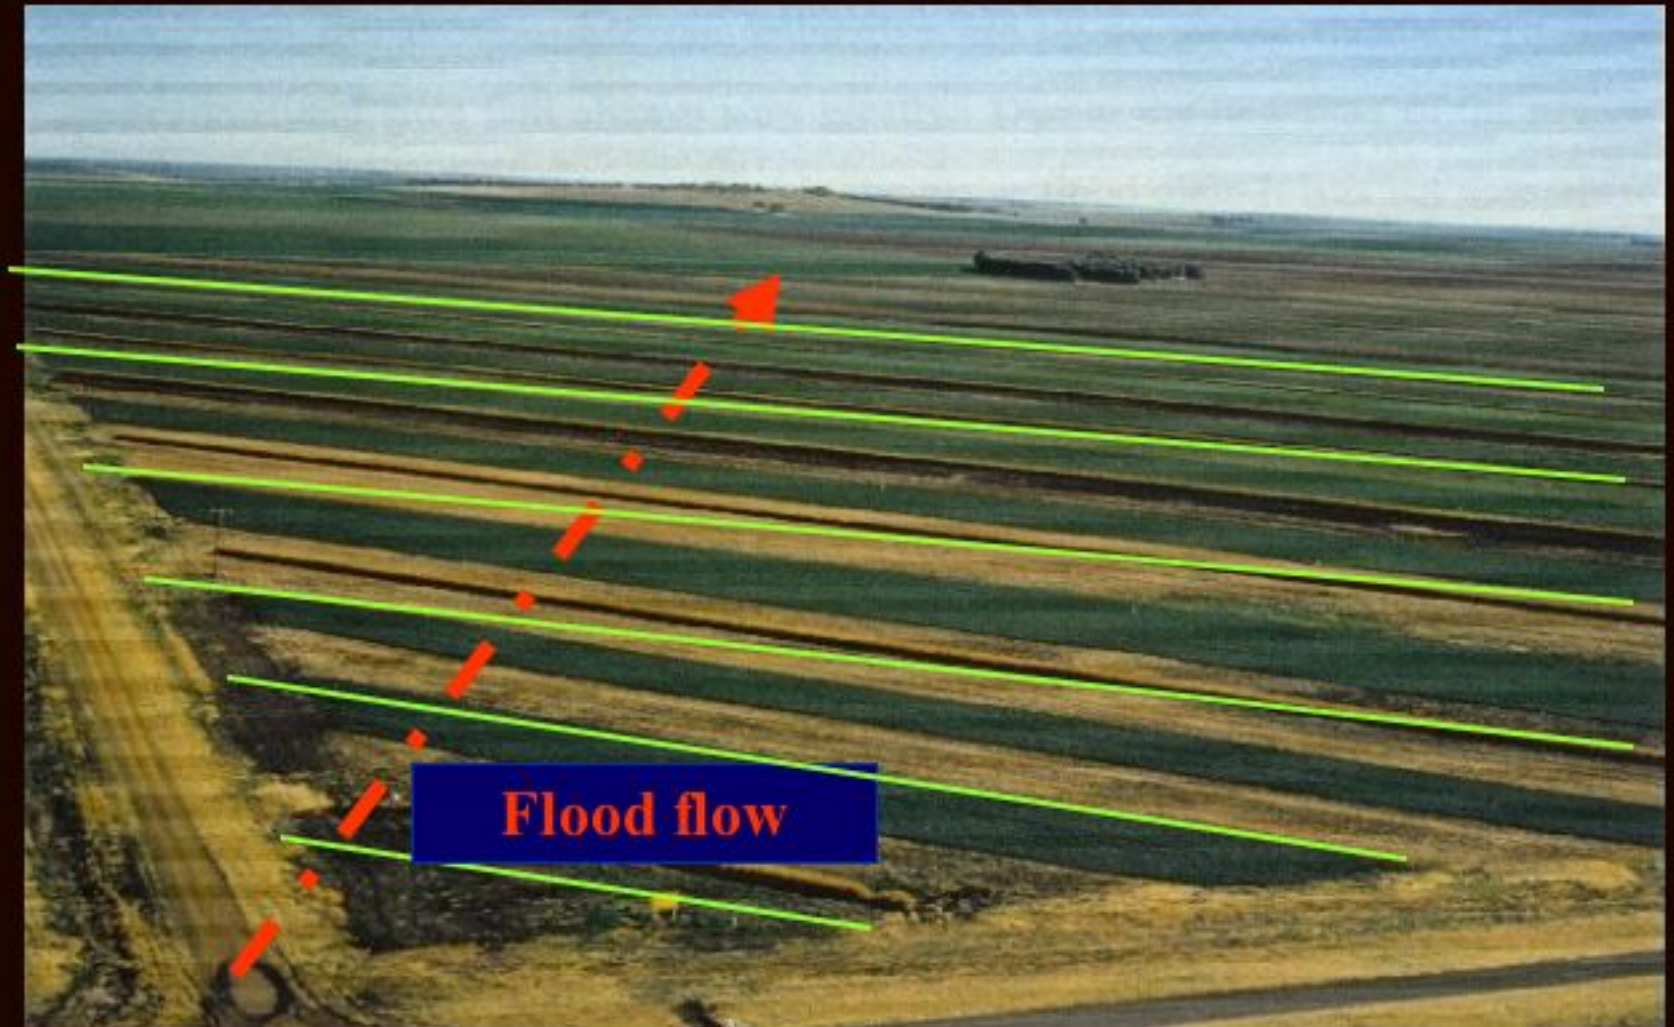
Australia: Flood erosion is often severe on the flood plain and this rich agricultural land is traditionally protected by strip cropping practice. Six rows of vetiver planted at 90m interval as an alternative flood erosion measure.

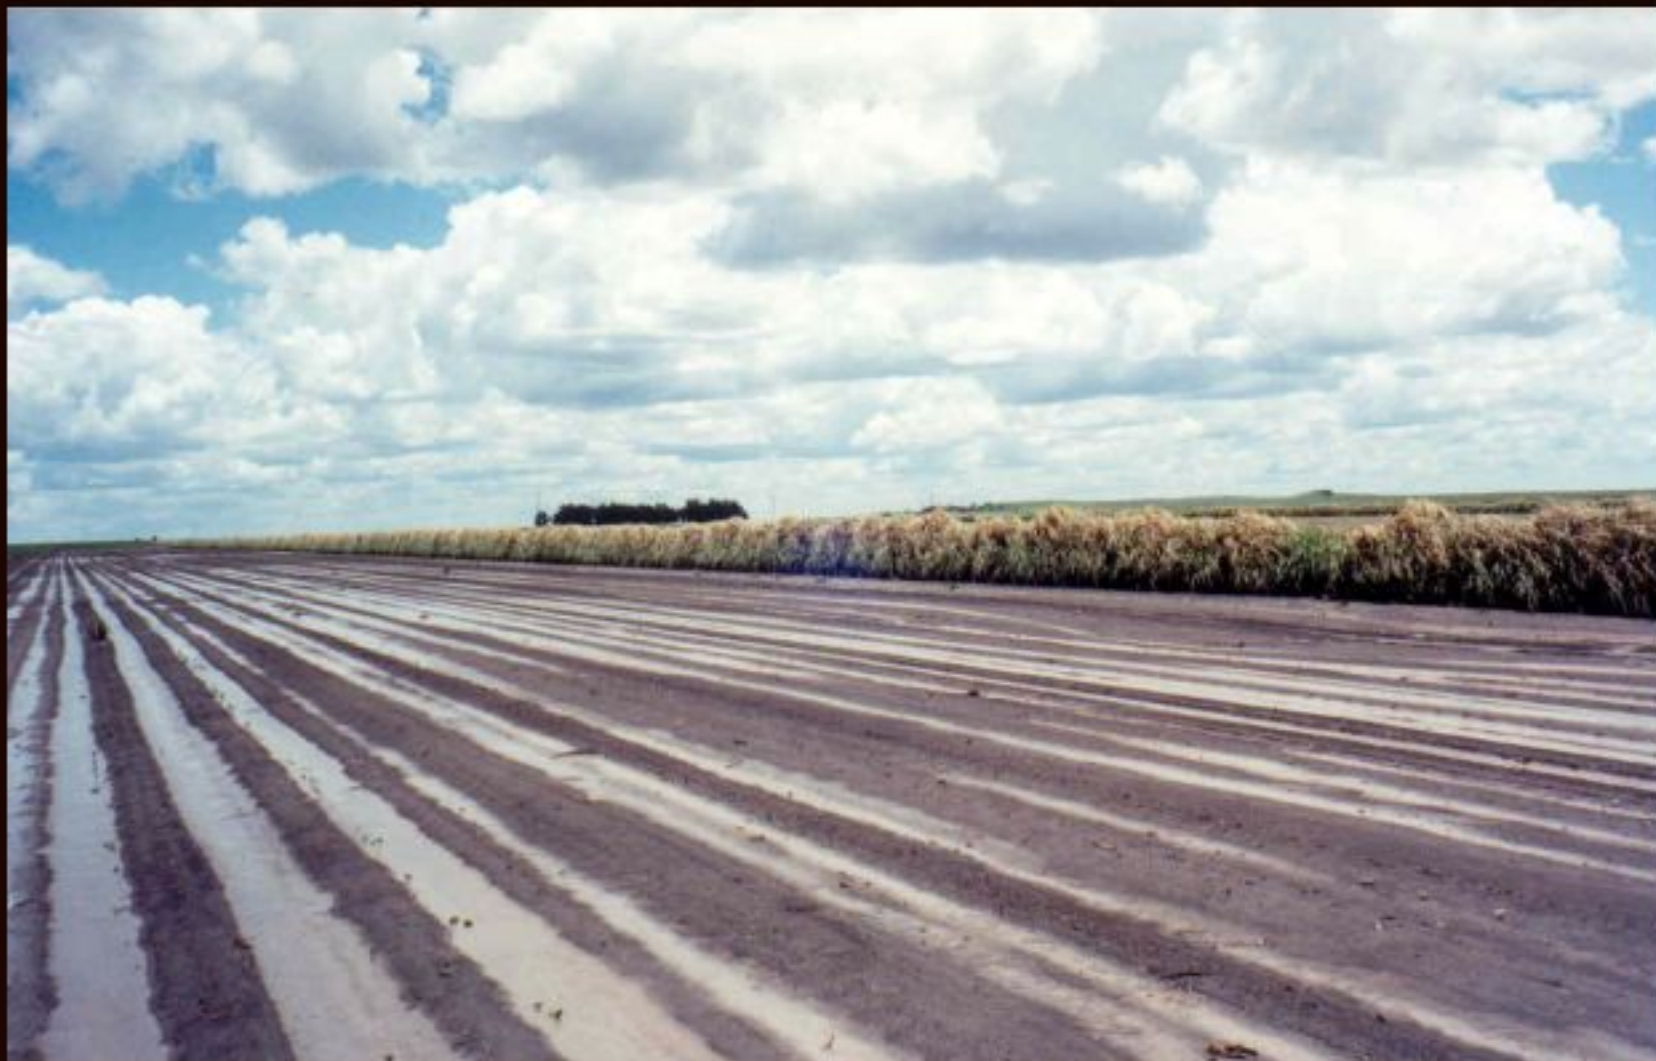
No sign of rill and minimal surface erosion

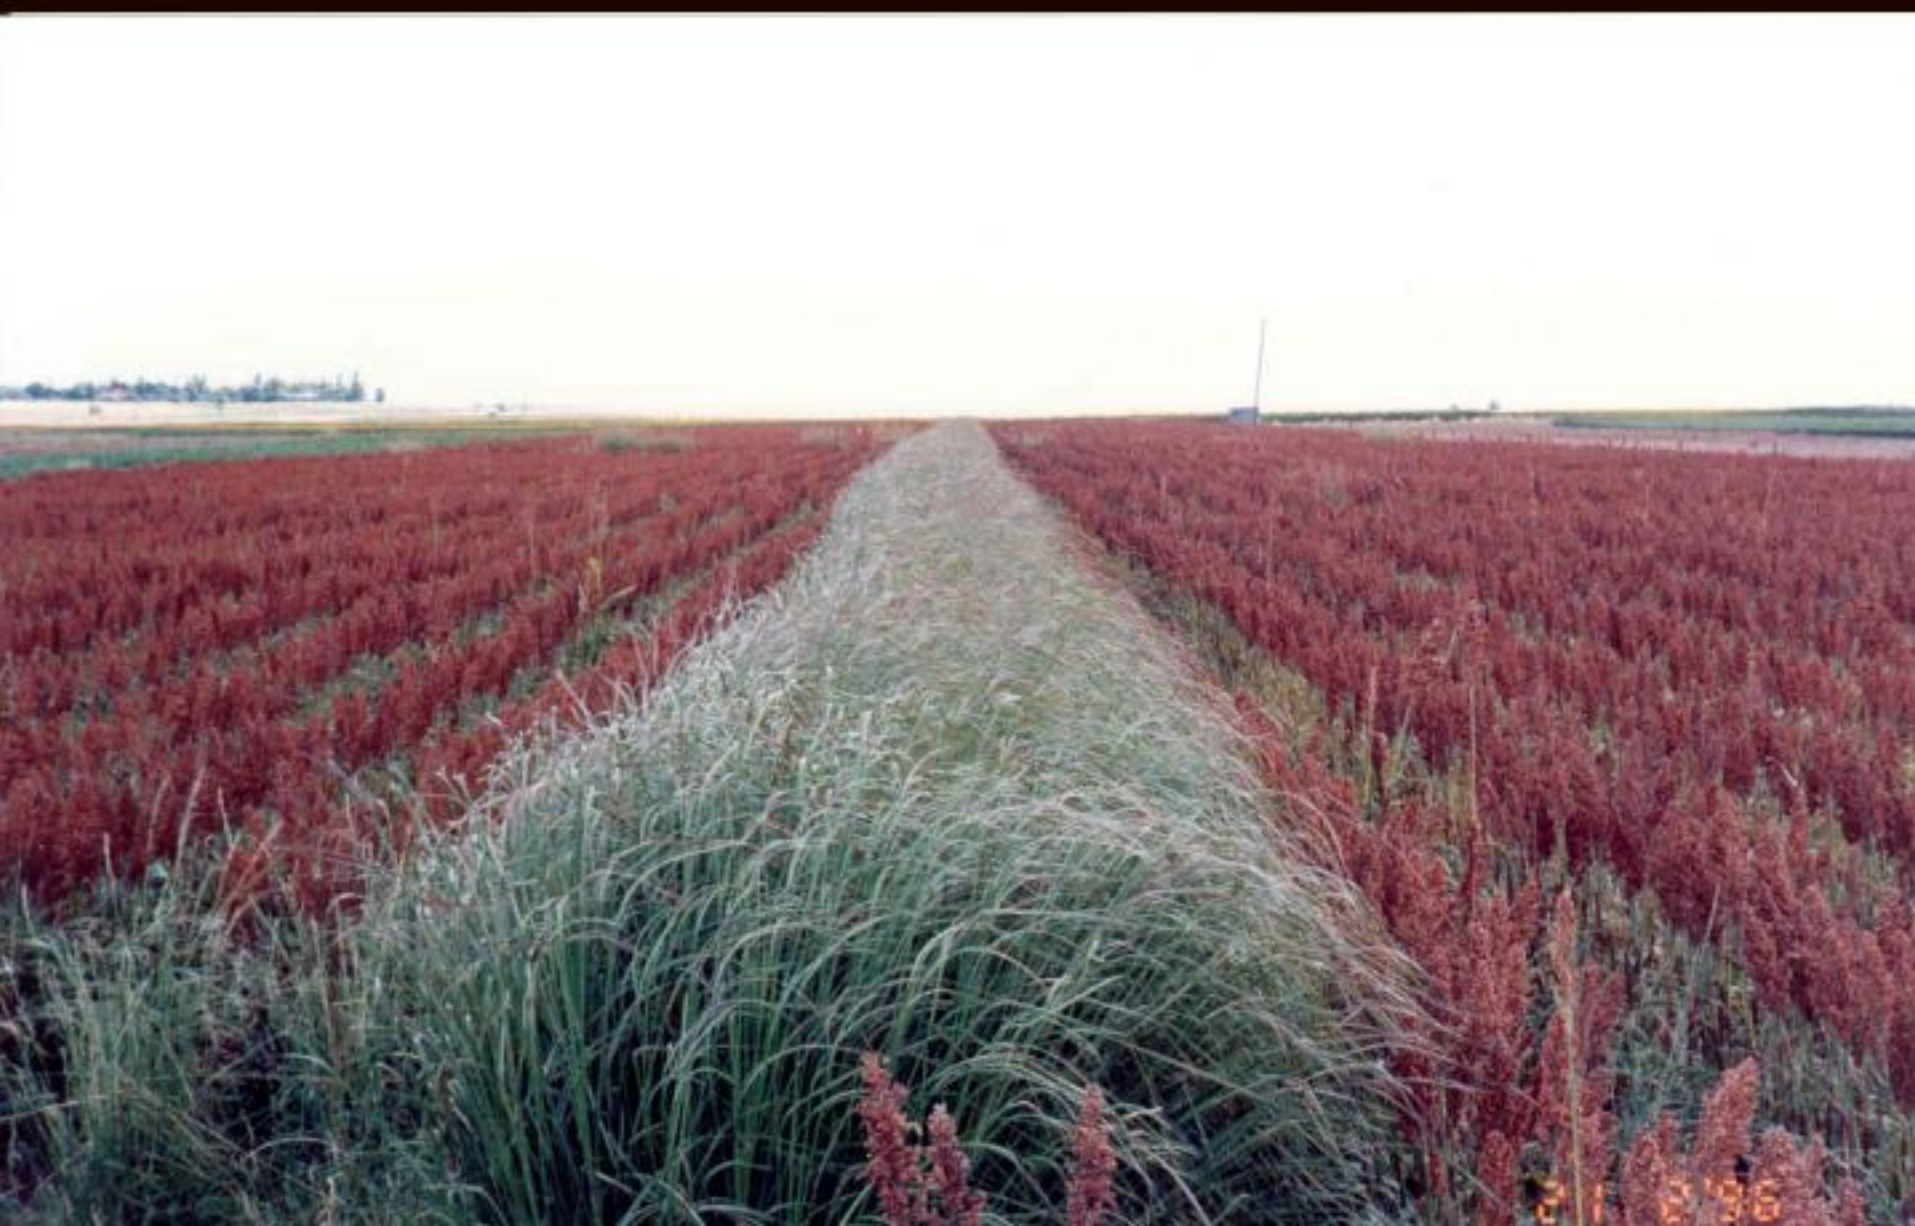
No flood damage and excellent crop of sorghum

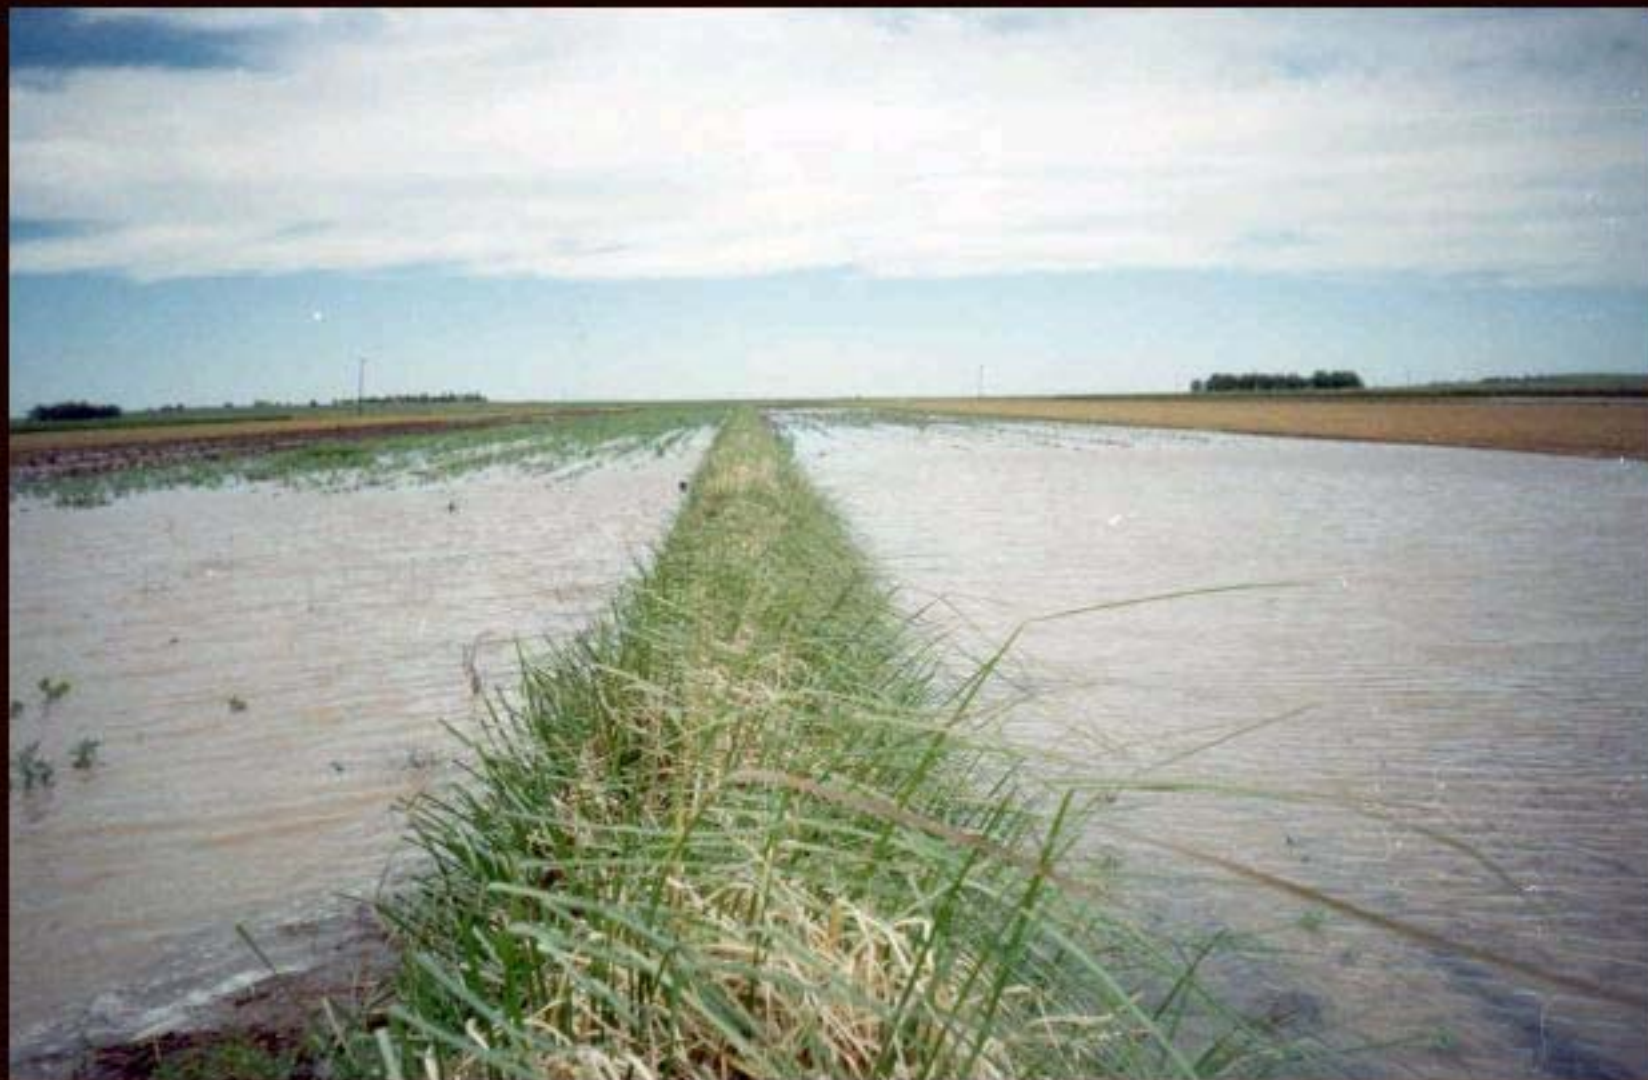
A major flood event in 1996

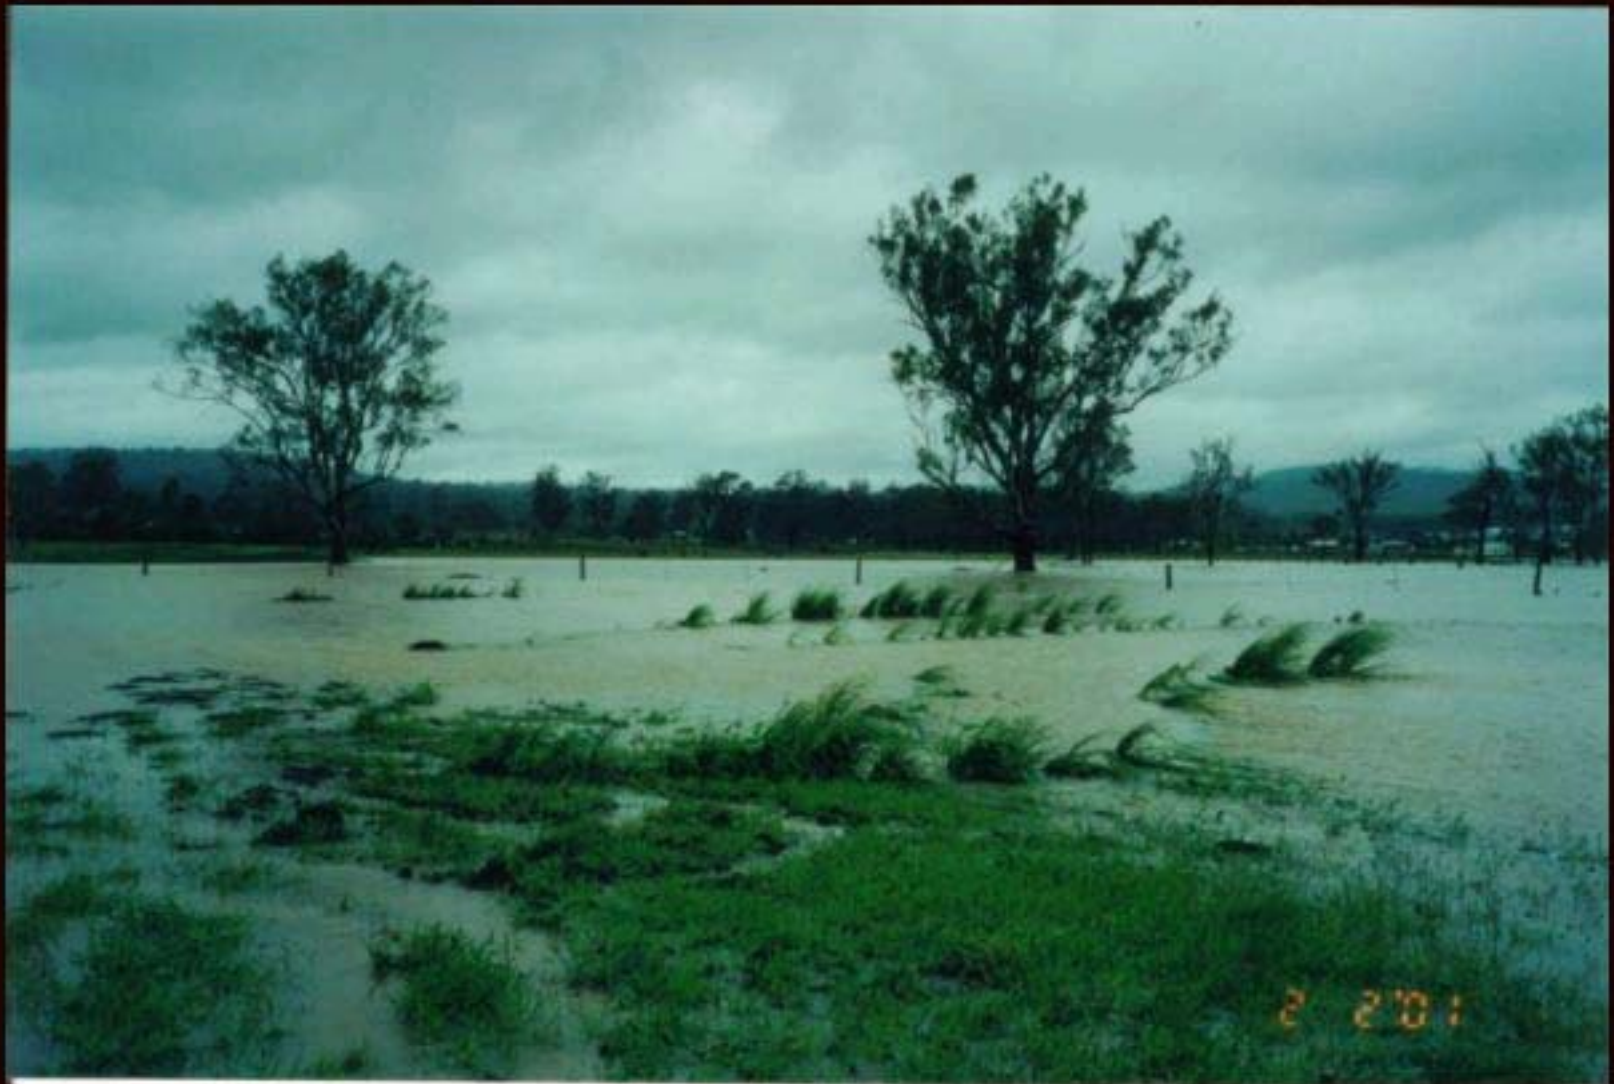
Australia: This drainage channel is often damaged by flood, note that vetiver hedges bent under strong current
