ROYAL BRIGHTON YACHT CLUB MARINA REDEVELOPMENT

Ray Tyshing - GHD Pty Ltd, 380 Lonsdale Street, Melbourne
tyshing@ghd.com.au

Abstract: Royal Brighton Yacht Club is one of the premier yacht clubs in Victoria catering mainly for racing yachts ranging from dinghies to ocean racing yachts. The timber jettied marina was in poor condition with rotting decks and piles subject to necking and other signs of age. This structure catering for up to 179 berths was originally constructed for the 1956 Olympic Games, and despite maintenance, was beyond its service life, and no longer met the expectations of the members. Following a lengthy approvals process and negotiation of a seabed lease, redevelopment of the marina was started in May 2002. The work was arranged in stages of demolition, dredging and reconstruction in three designated areas of the marina, in order to provide continued berths for a majority of its fleet and minimise disruption to the Club.

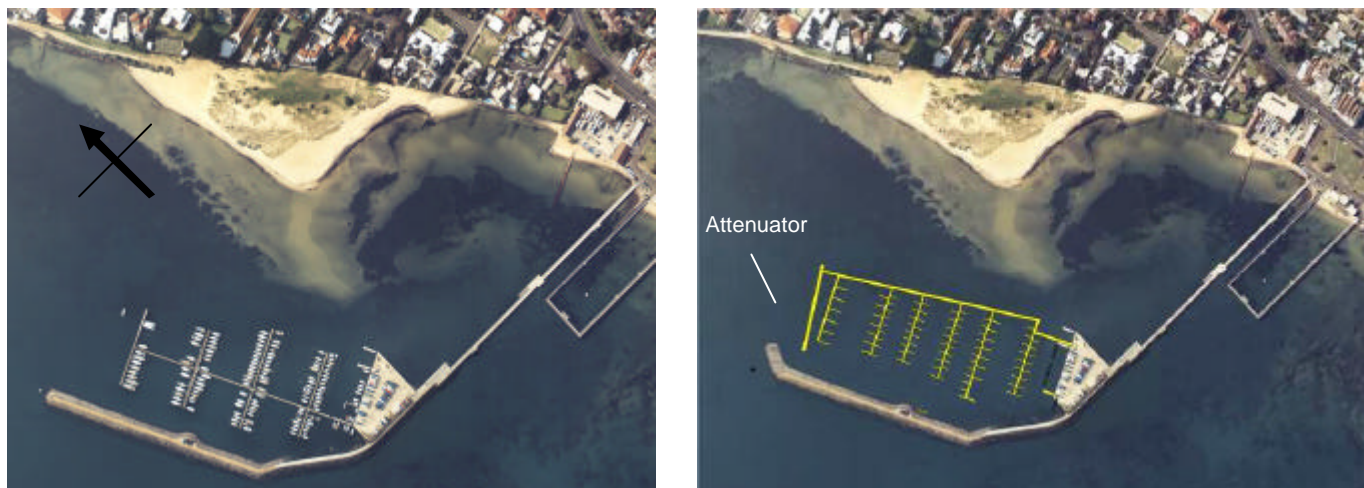
Figure 1. Pre construction marina and simulation of completed marina

In May 2002, a contract was signed for the design and construction of the new marina, to provide a 1 for 1 replacement of berths. Soon after, work commenced on site.

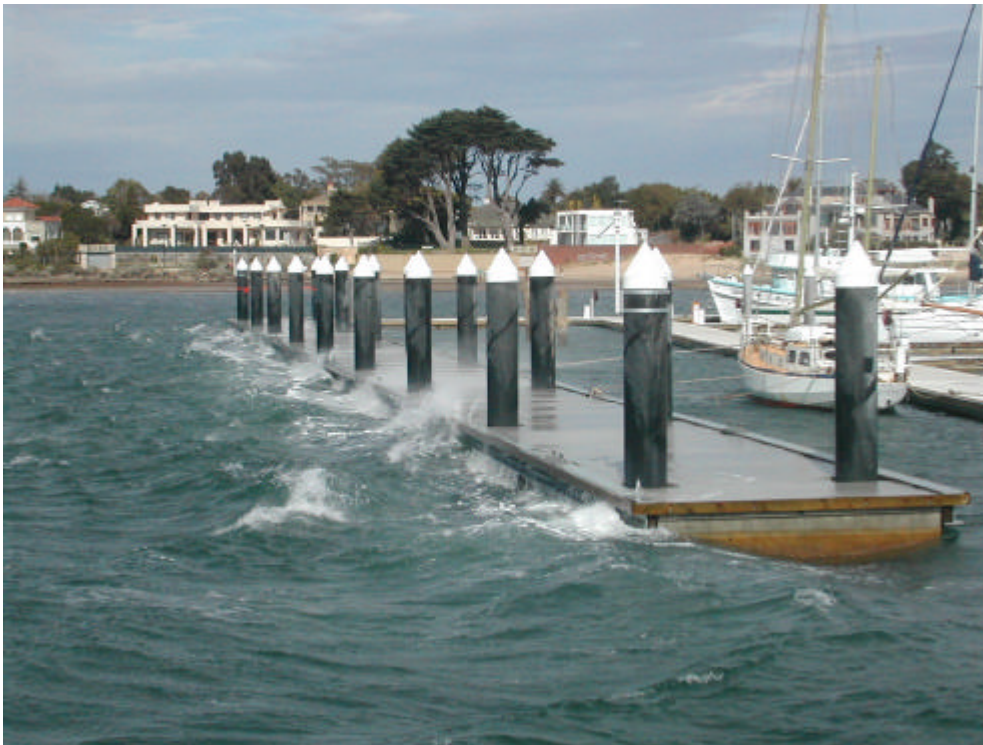
Fig 3 Floating Wave Attenuator

Principle dimensions of the wave attenuator adopted are length 110m, nominal width 4m, draft 1.8m and freeboard 0.5m. The attenuator accepted is of straight form and is constrained in place by 18 circular steel piles, sand filled. The original concept was for a curved attenuator, the theory being that the curved shape is better able to resist a straight wave front that approaches the attenuator. In

practice the contractor was unable to roll the steel connecting walers to achieve this shape, and hence the straight shape was accepted. At some other locations where this type of attenuator has been installed, the steel piles were connected at the top by steel cross connecting yokes to stiffen the restraint system. This design was considered to be aesthetically unacceptable and not in conformance with the Planning Approval and hence the unconnected pile design was accepted.

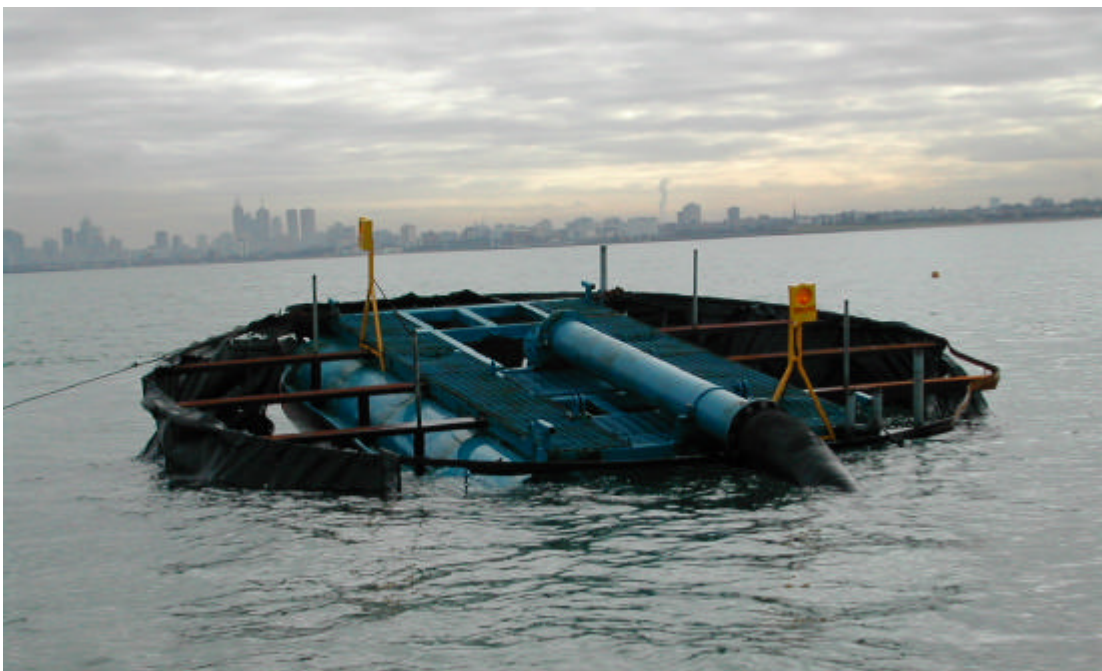
Fig 4 Cooking Pot (Mark 1)

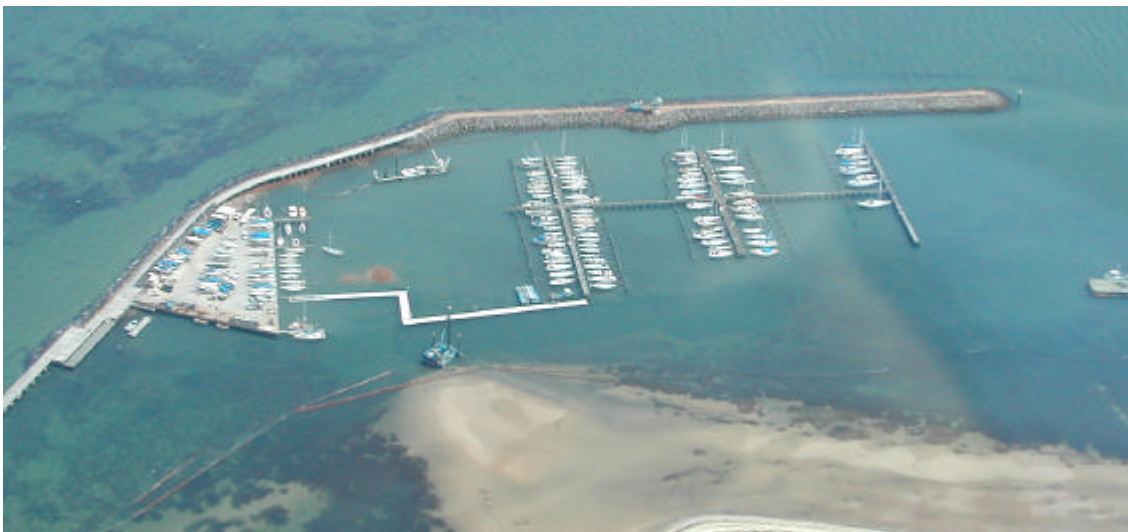
Fig 5 New Marina in progress (pre the floating arms and wave attenuator)

Piling for the marina was undertaken from a barge fitted with two stabilising spuds, with location of the barge controlled by anchors and wires to winches. For marina piling, tight tolerances within the range of the adjustment of the pile guides on the pontoons is necessary and this dictates a tolerance in horizontal positioning of better than +/- 20mm. In virtually any conditions other than fairly quiet winds, positioning of the barge to hold a location within tolerance proved to be slow and cumbersome. This and the need to pre auger some pile locations translated into typical pile installations of only two per day.
